CRUISE REPORT 2022106

MAREANO methods cruise: AUV testing (Munin +)

Author(s): Rebecca Ross, Kyrre Heldal Kartveit, Karsten Arne Kvalsund, Arnfinn Morvik (IMR), Margaret Dolan (NGU), Tor Jan Meek (Kartverket) and Ivar Wangen (Kongsberg)
Cruise leader(s): Rebecca Ross (IMR)

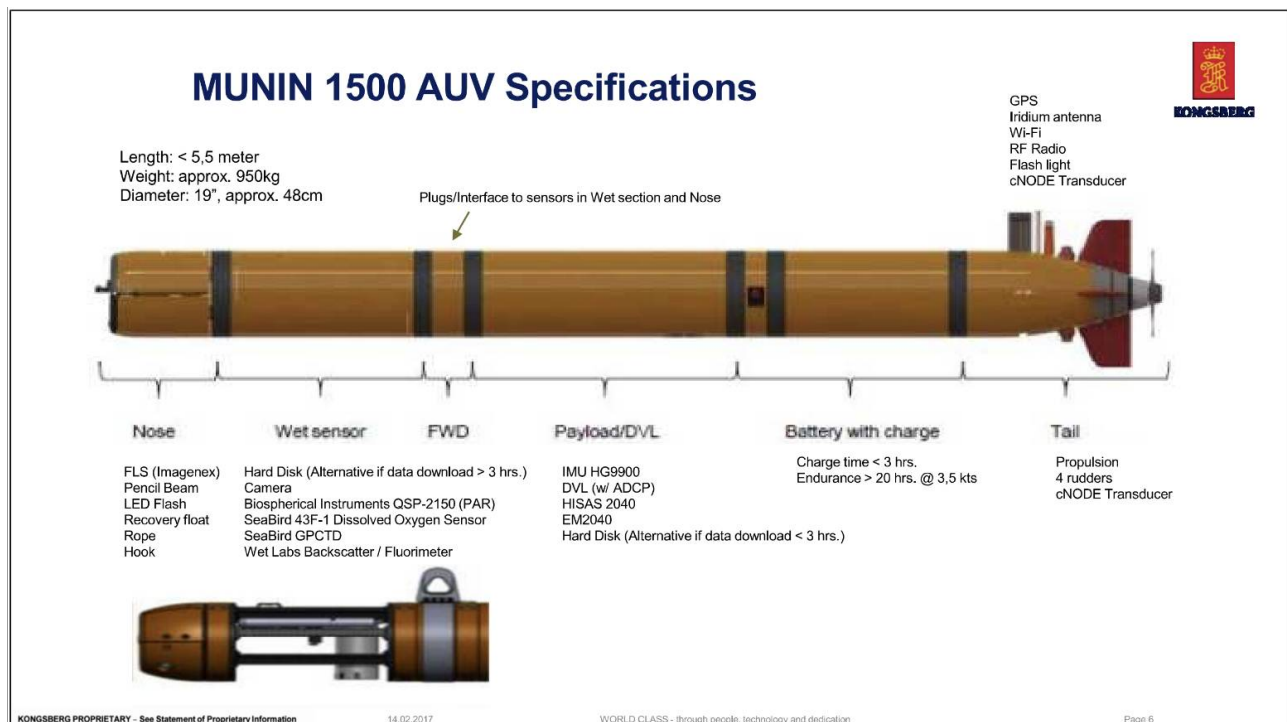
HISAS 20401:

"HISAS bathymetry, combining HISAS and EM2040 MBES in HUGIN and MUNIN 1500+... In addition to the HISAS the AUV is equipped with an EM 2040 multibeam echo sounder (MBES), combining the HISAS and MBES results in a coverage for a singular track of more than 20 times the flying altitude above the seabed of the AUV used compared to 3-4 times the altitude using MBES alone." <https://argeo.no/referanse/side-scan-sonar-sss-og-hisas/>

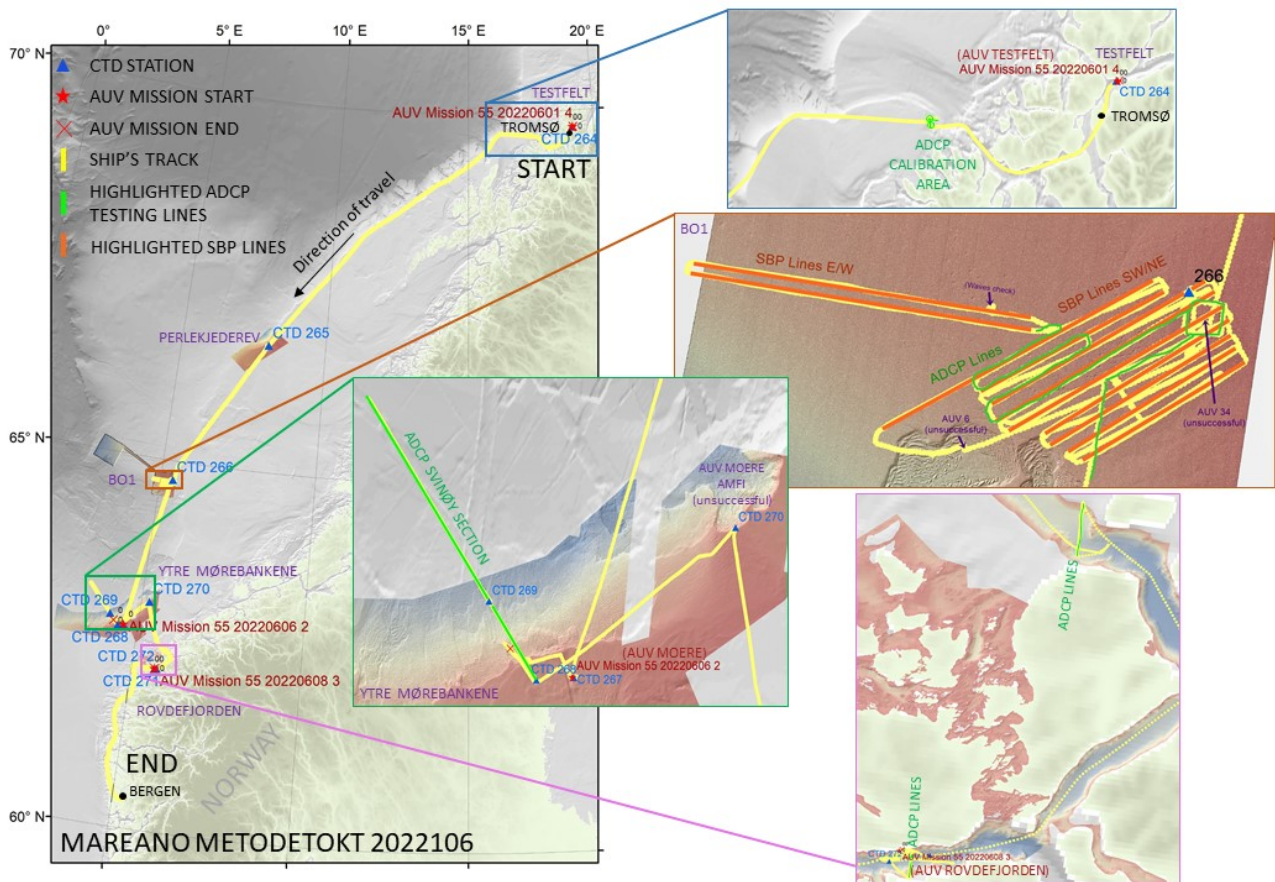
Map of cruise track starting at Tromsø in the north and heading south to Bergen. Inserts show greater details in subregions.

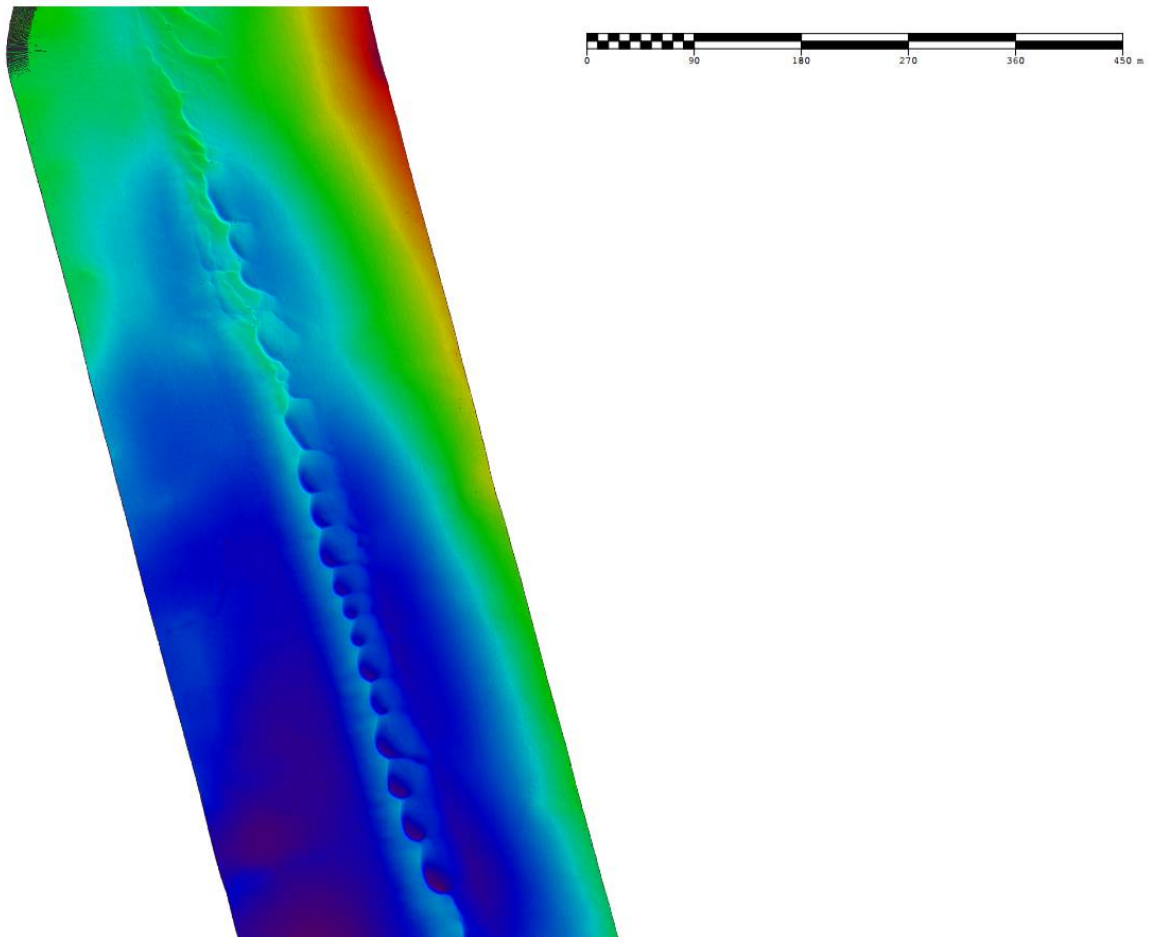
Image shows multibeam bathymetry from AUV Møre (Mission 55 20220606 2) and the sand wave feature at the start of the dive, processed in Caris by Tor Jan Meek.

At the Tromsø test site there was an issue with an average 20cm difference in depth between overlapping swaths, with the photo lines (up /down slope) showing 20-50cm discrepancy. However this seems to have resolved at subsequent sites without any action taken. Apart from the problems at the Tromsø test site, the MBE data so far has been of very good quality. The MBE data from Mørebanken is much more consistent and of very good quality. Hardly any noise, just a few outliers which is expected, but no “real noise”, no visible sound velocity error, no visible position drift and less than 10cm depth difference between survey lines.

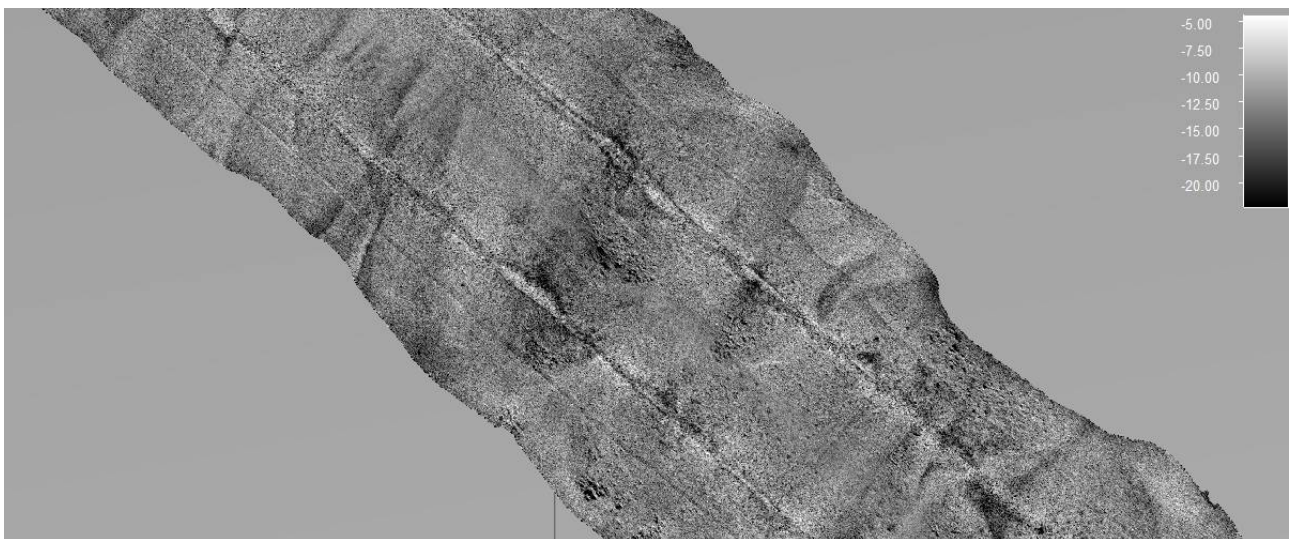
Example NGU processed backscatter data (FMGT) from AUVMøre_VL1293 (Mission 55 20220606) showing along track striping (sector problems?)

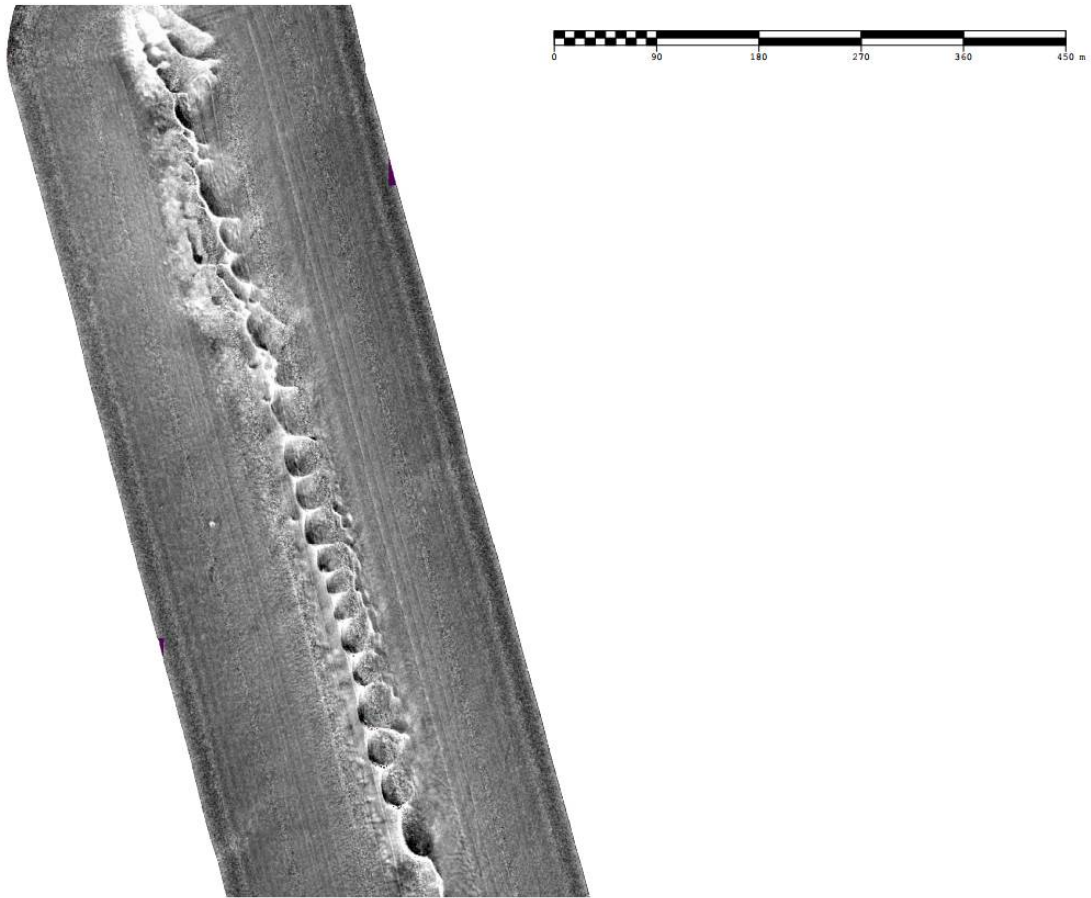
Example Kartverket (CARIS) processed backscatter from AUV Møre (Mission 55 20220606 2) and the sand wave feature at the start of the dive

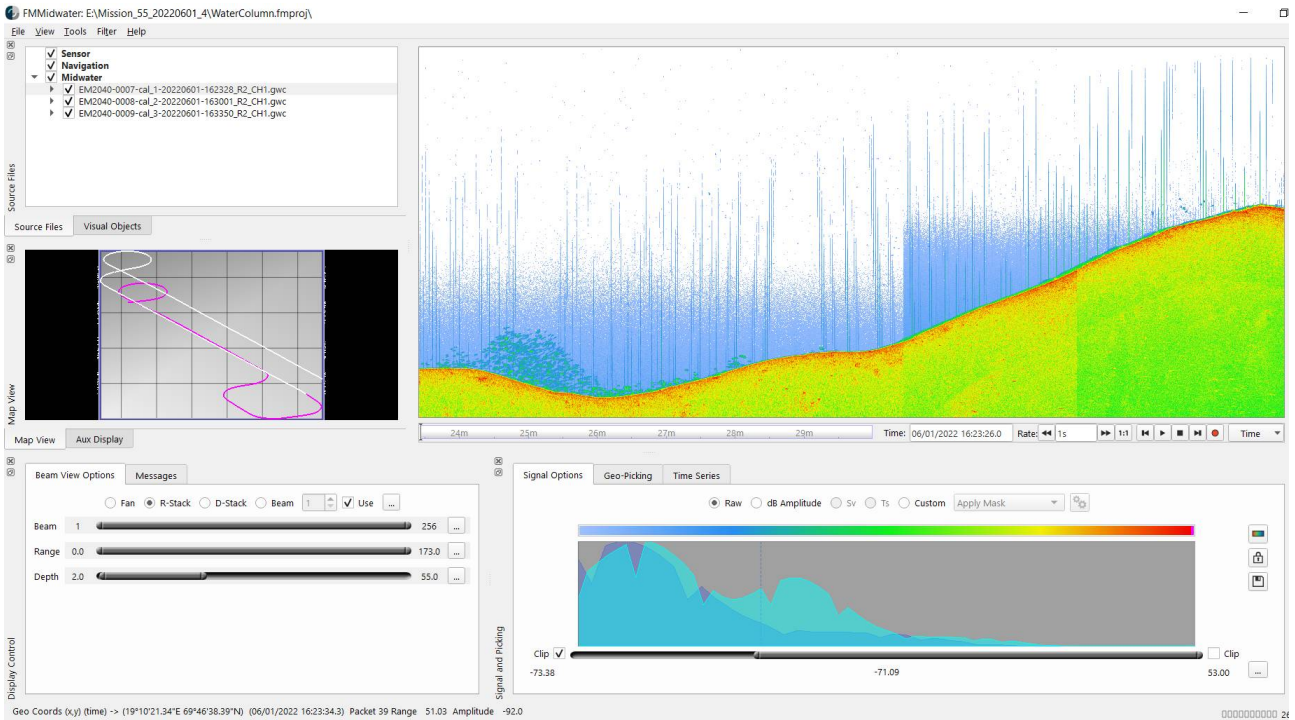
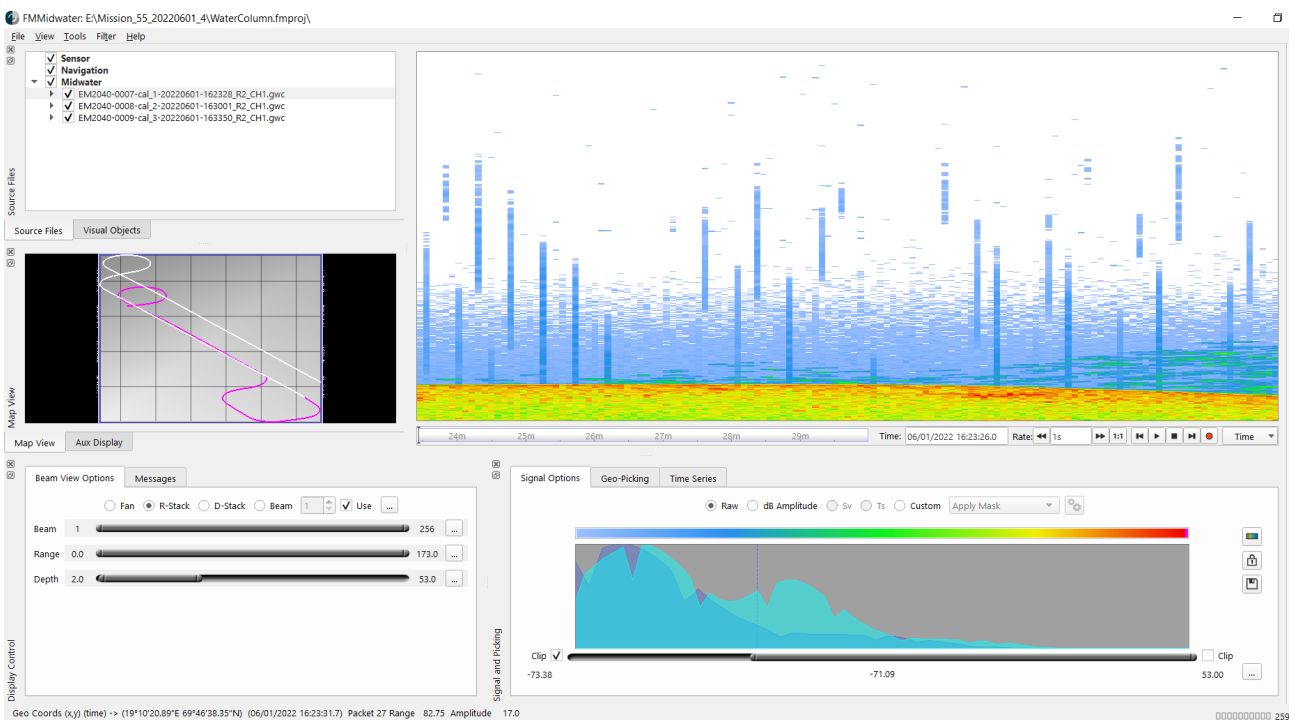
Example data from test area Tromsø – noise appears as vertical striping.

Water column data is fine but interference from other systems were noticed. More testing is needed to single out the noise sources and efficiently avoid them.

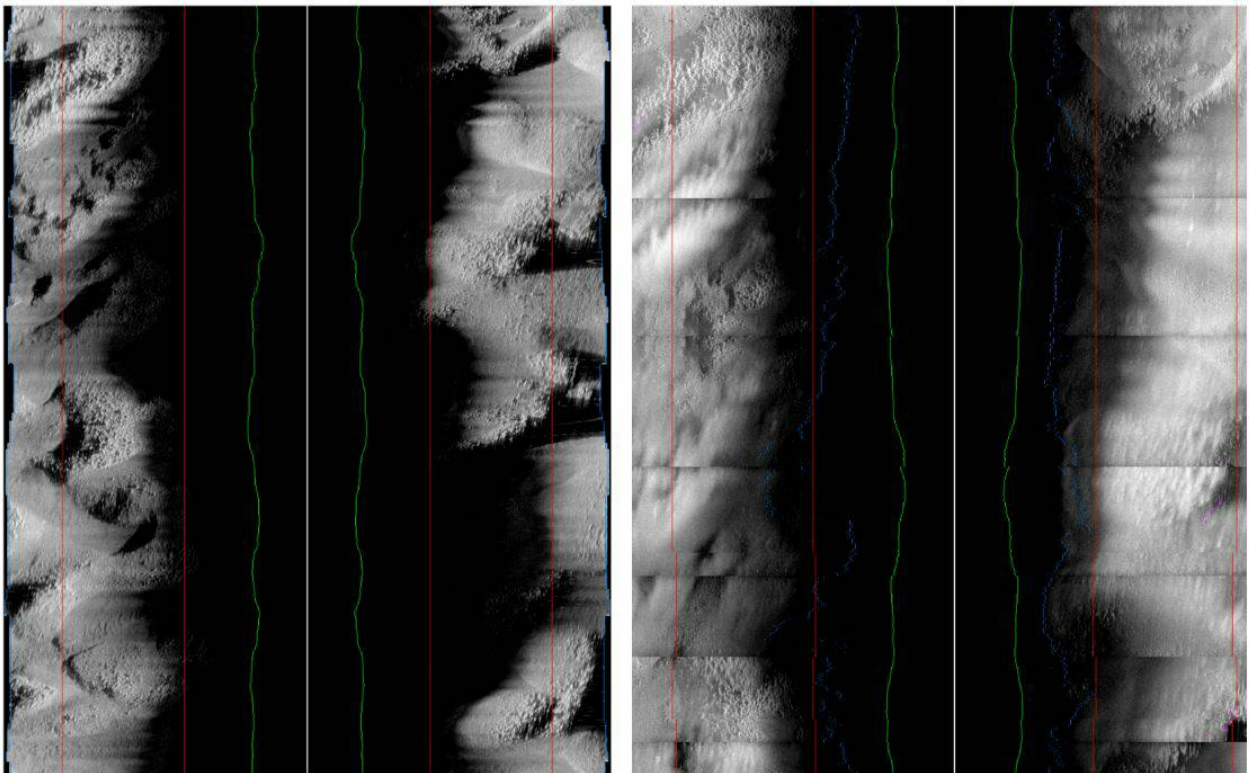
Comparison between the “sss” (left) and “HiSAS imagery” (right). The resolution of the sss-data is low, but the data is consistent, while the resolution of the HiSAS is high but the consistency is poor.

The HiSAS imagery as seen after the on-board processing was not as good as expected. The processing algorithm seemed to struggle to display the data correctly in the Reflection software. As seen on the figure, the resolution of the data is impressive, but the dataset is severely obscured by some sort of artificial striping perpendicular to the flying direction. The sharp stripes occur on the border between the individual sas-files (each <100 MB), but blurry lines are related to the processing algorithm. Part of the reason of this is believed to be a software issue and it is believed that the quality of the data will be much better after proper processing, but it is likely that as we gain more experience and are able to plan HiSAS surveys in more detail that this will also improve the results. The HiSAS processing algorithm favours a flat seabed, and the instrument is very susceptible to “pitch” and “crab”.

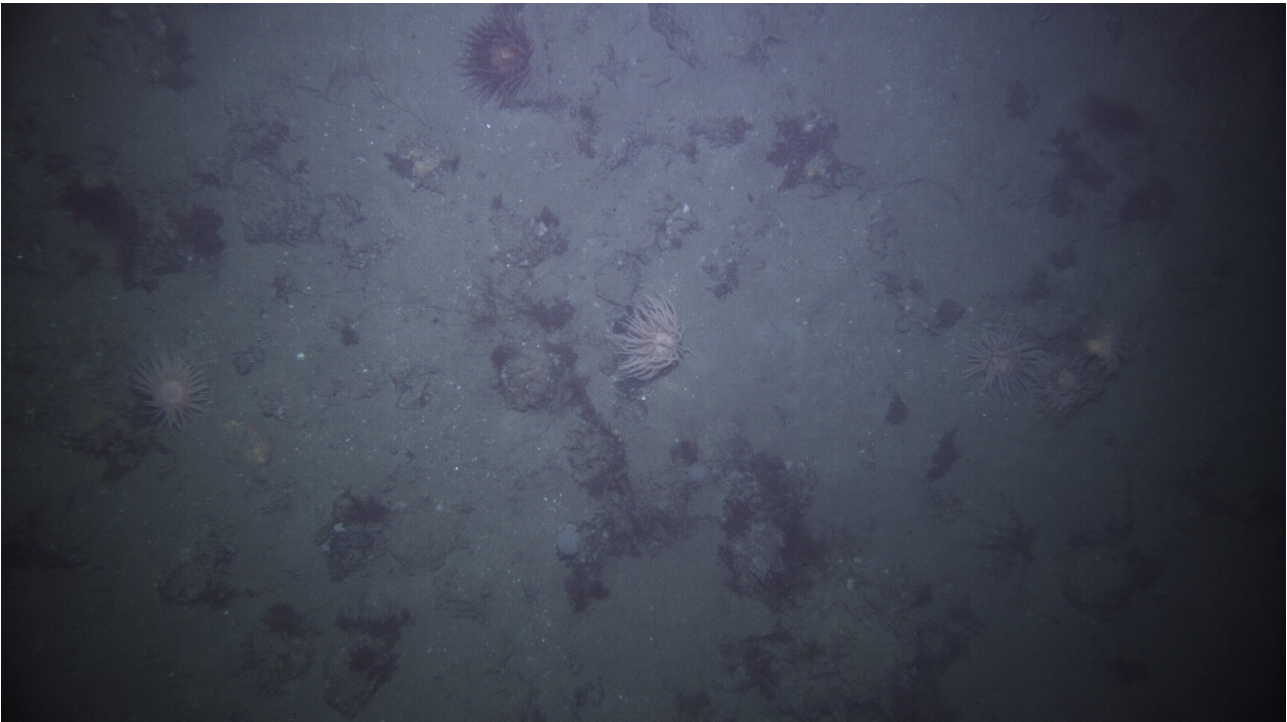
Example photo from 5m altitude at the test site (unedited)

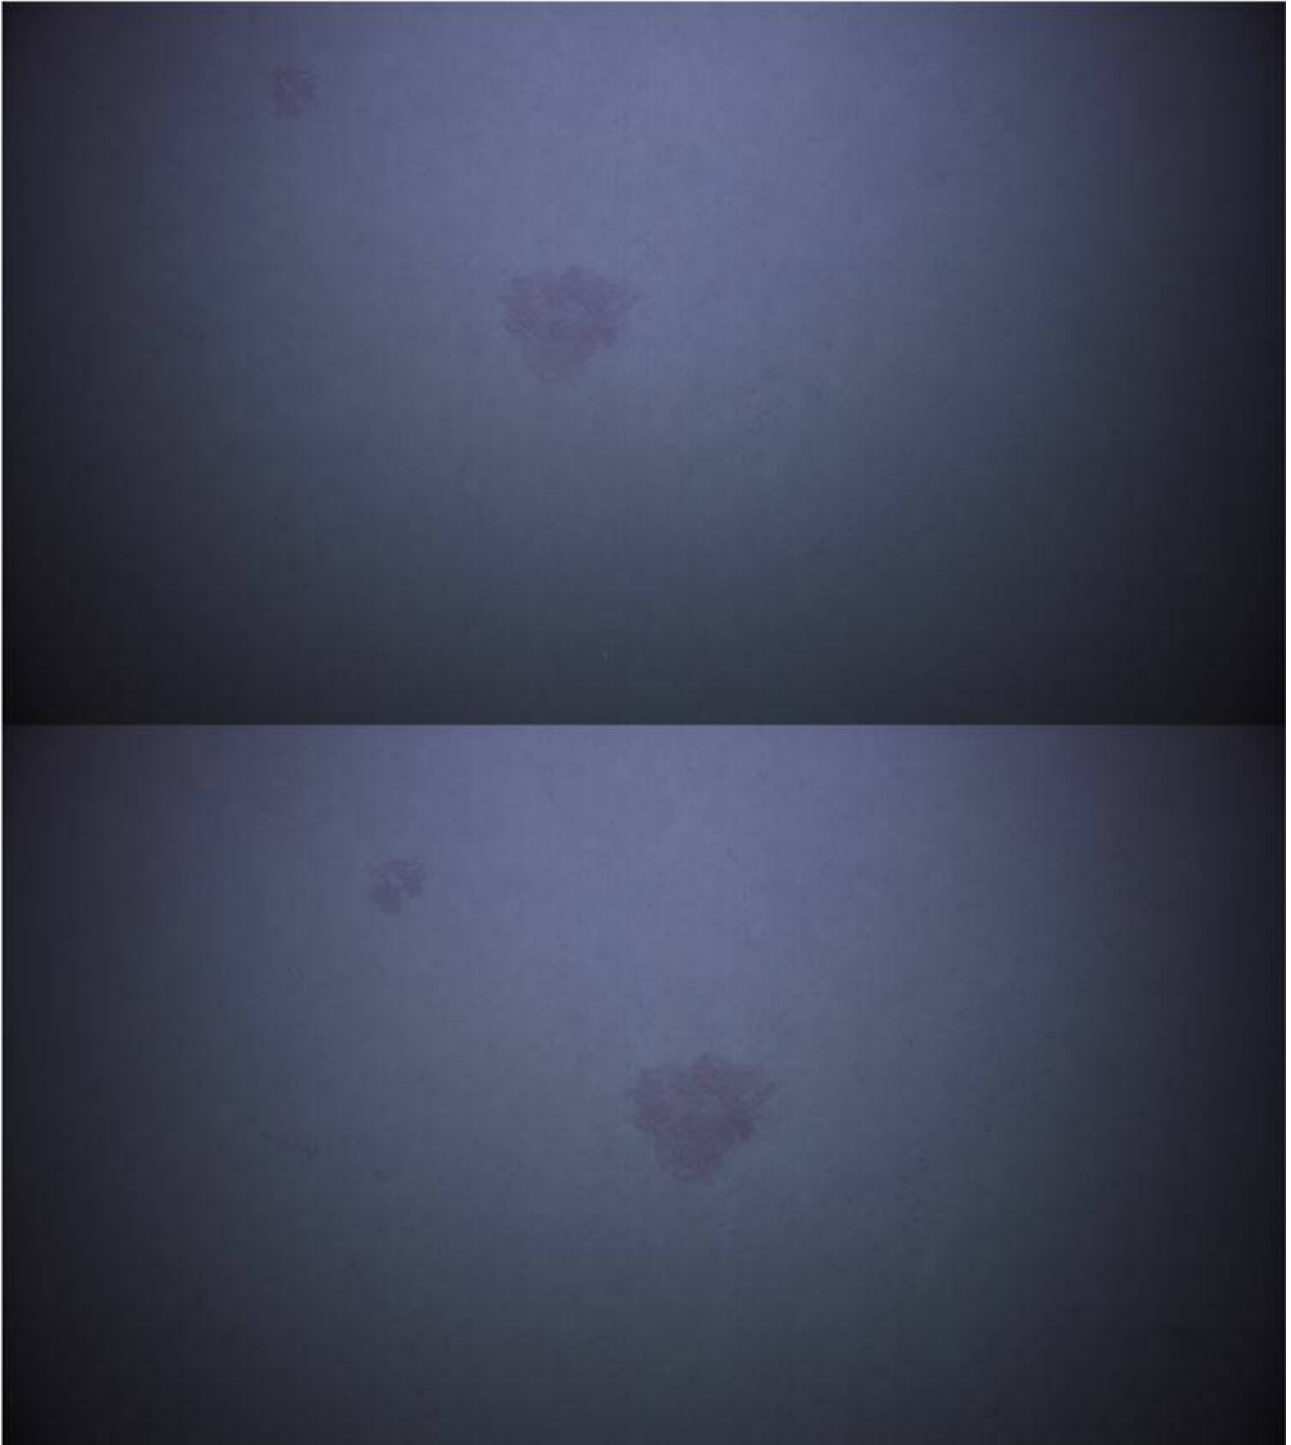
Example photos from the AUV: testing heights - a discarded chain at the test site is visible in both 6m (top) and 5m altitude photos (bottom) – both are unedited.

Photo lines have been tested successfully at 6m, 5m and 4m altitude, although note that despite having 4m altitude set at AUV Møre the rough terrain of the coral reef on a slope meant that the AUV did get to within 2.6m of the bottom at one point before recovering and re-gaining the programmed 4m altitude. Lower altitudes are therefore not recommended on rough terrain, but could be possible on flat sediment bottoms.

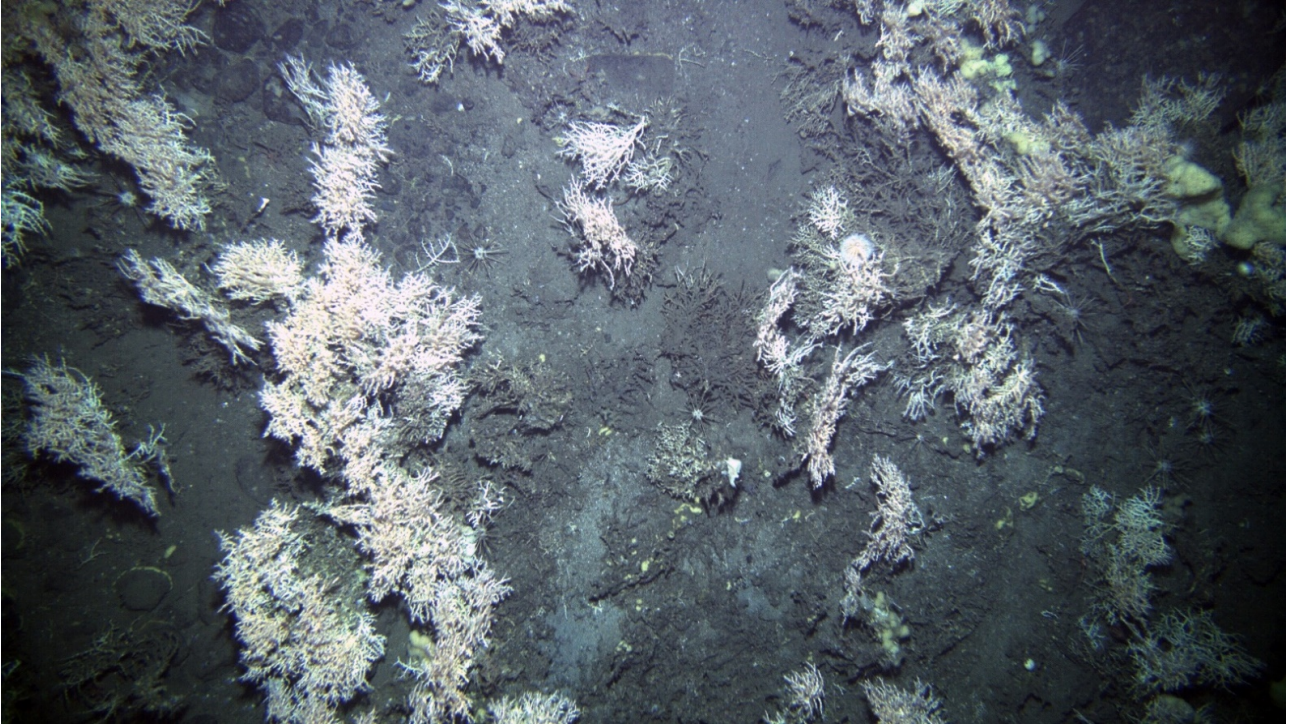
Photo from AUV Møre taken from an altitude of 4m over a coral reef (includes some colour corrections)

The successful AUV Møre reef photos were taken at 4m altitude on the downslope. The same VL was attempted first in an upslope direction (again with 4m altitude programmed) but the terrain avoidance measures, coupled with an over cautious "safe height" resulted in most images being taken at 8-10m off bottom which is confirmed too high to be of use.

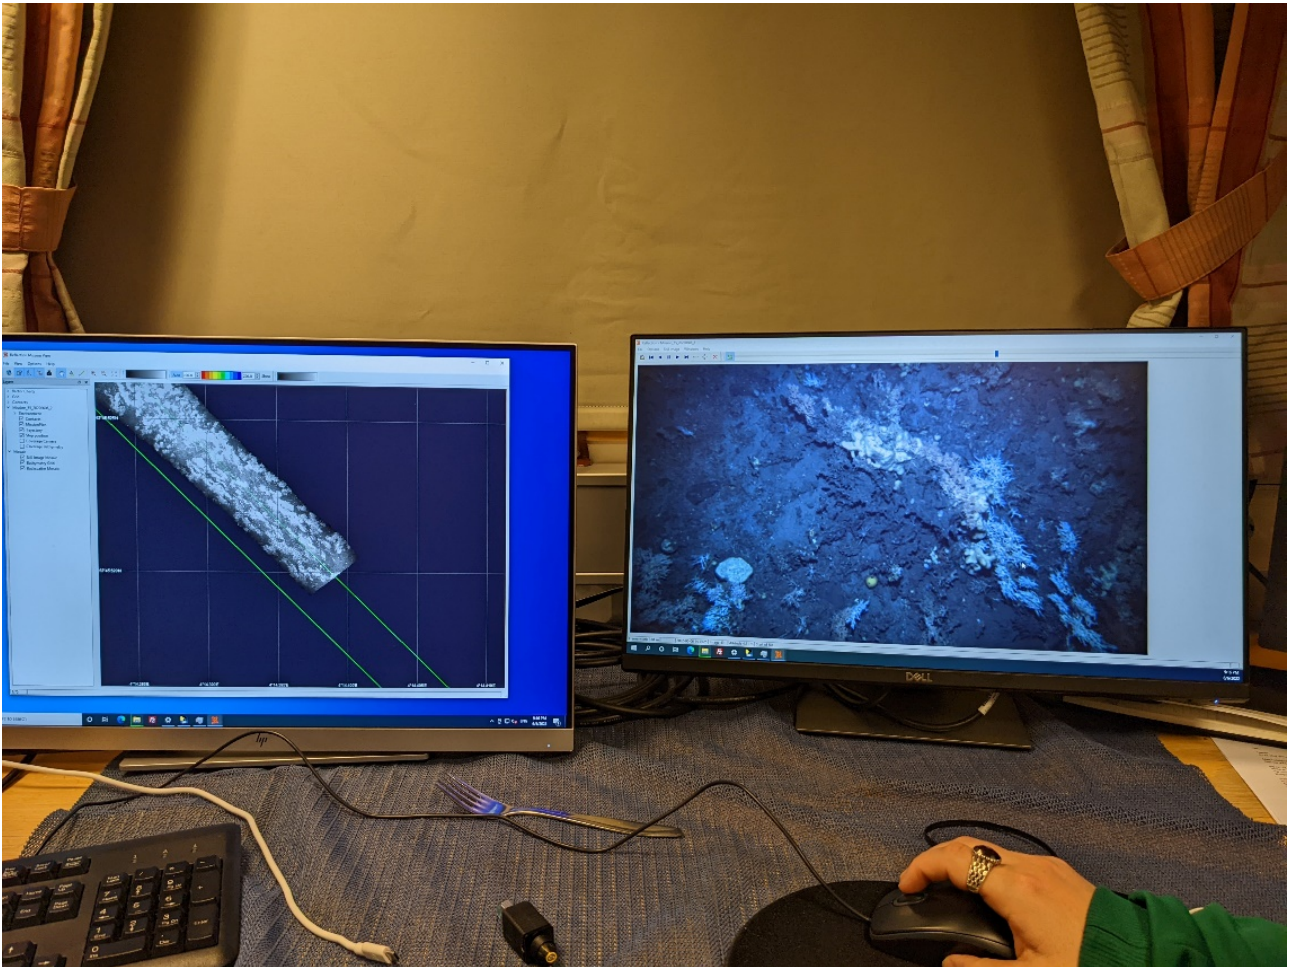
View of reflection software showing a photomosaic of images plotting on the downhill pass of the photoline1293 at AUV Møre.

View of photomosaics in the Reflection software is possible had some success (see screenshot below). Reflection plots the images one by one in sequence and shows how they overlap (you must wait for this process to finish to see the photomosaic of the desired line/area). Exporting photomosaics must be done at low resolution, in black and white and with a limit to what number of images can be included in each saved file (seemed like ~100m of straight line could be saved in one go with 1cm resolution. Investigations are ongoing as to whether a 3rd party software can improve outputs with colour photomosaics preferable if possible.

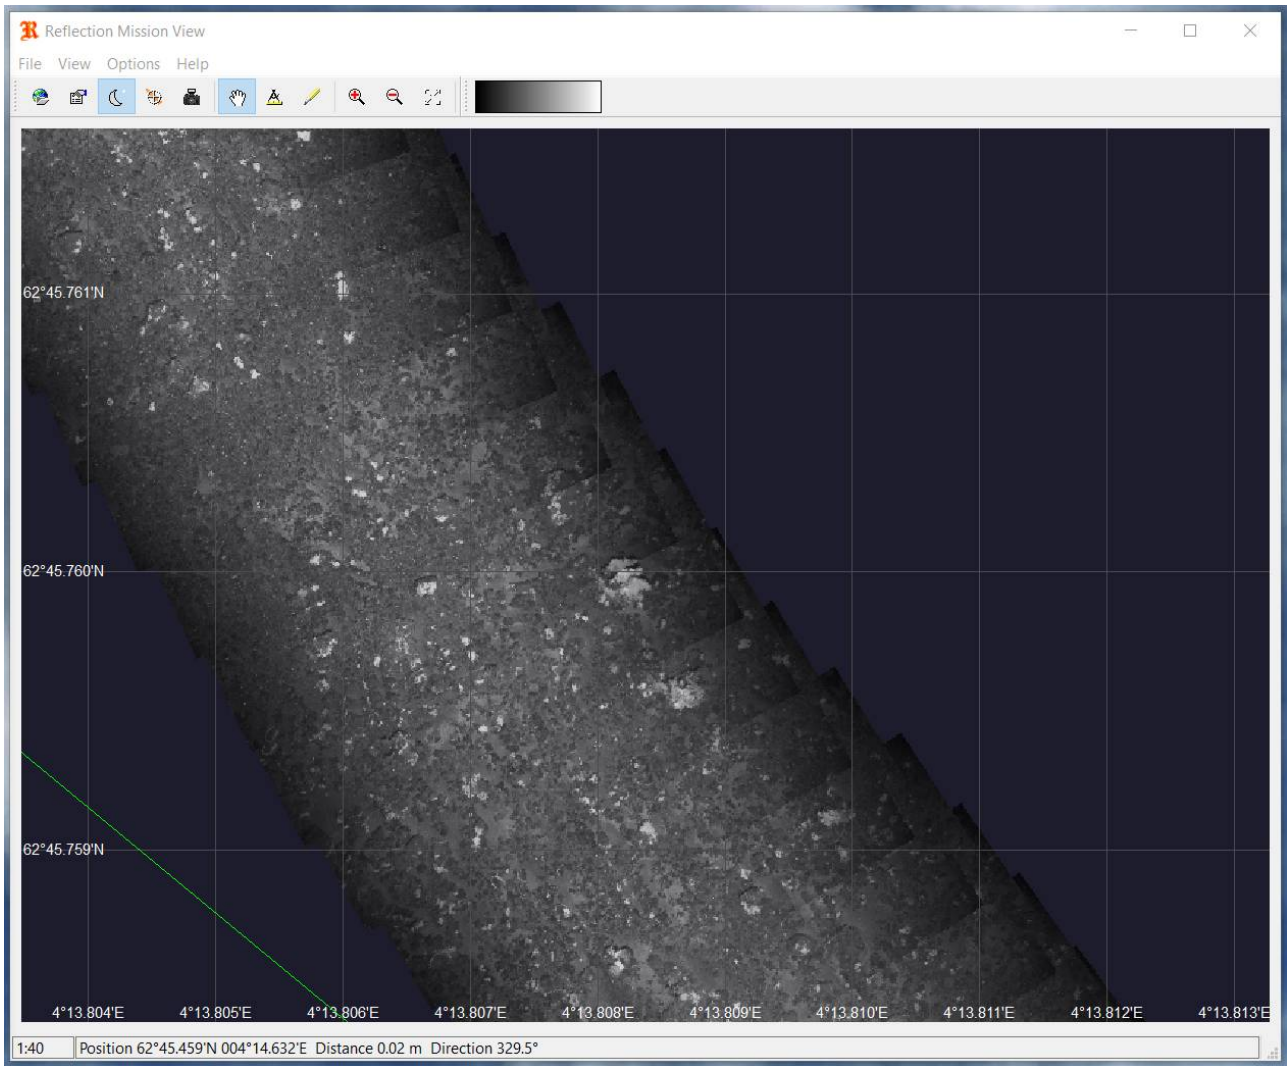
Example of photo mosaic at 1cm resolution from the 4m altitude downhill run at photoline1293 at AUVmøre, white marks are sponges and corals. Note that averaging must be switched on in "Still Image Mosaic Options" otherwise the image will blur with slightly misaligned images.

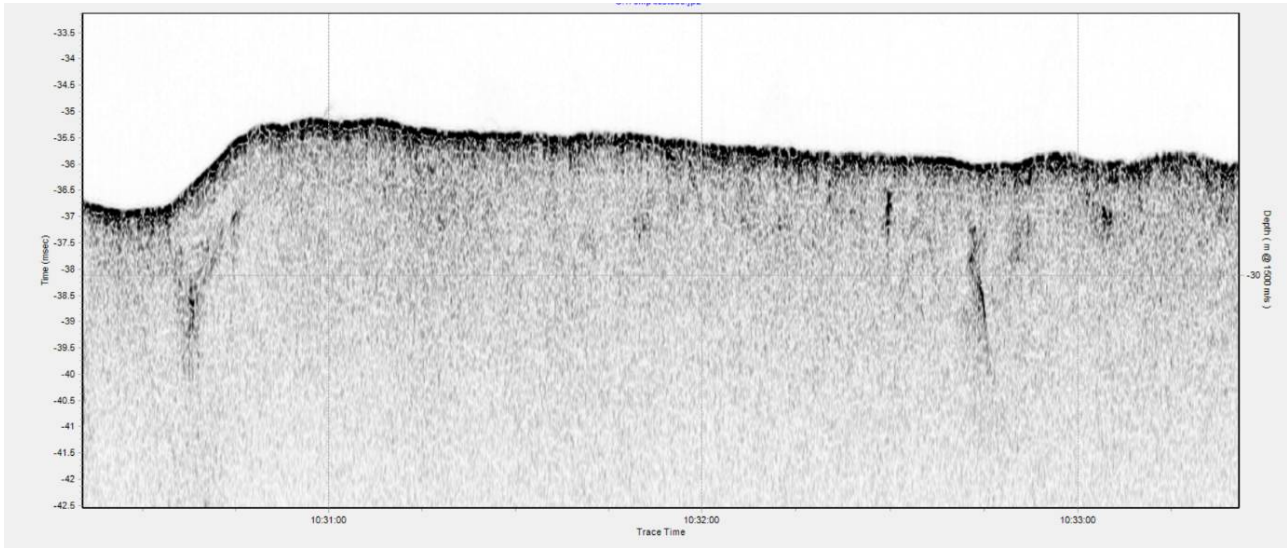
Example sub bottom profiler data from AUVMøre VL1071

SBP data looks fine, but the areas investigated do not have much stratigraphy to check the penetration capabilities. Further testing is necessary.

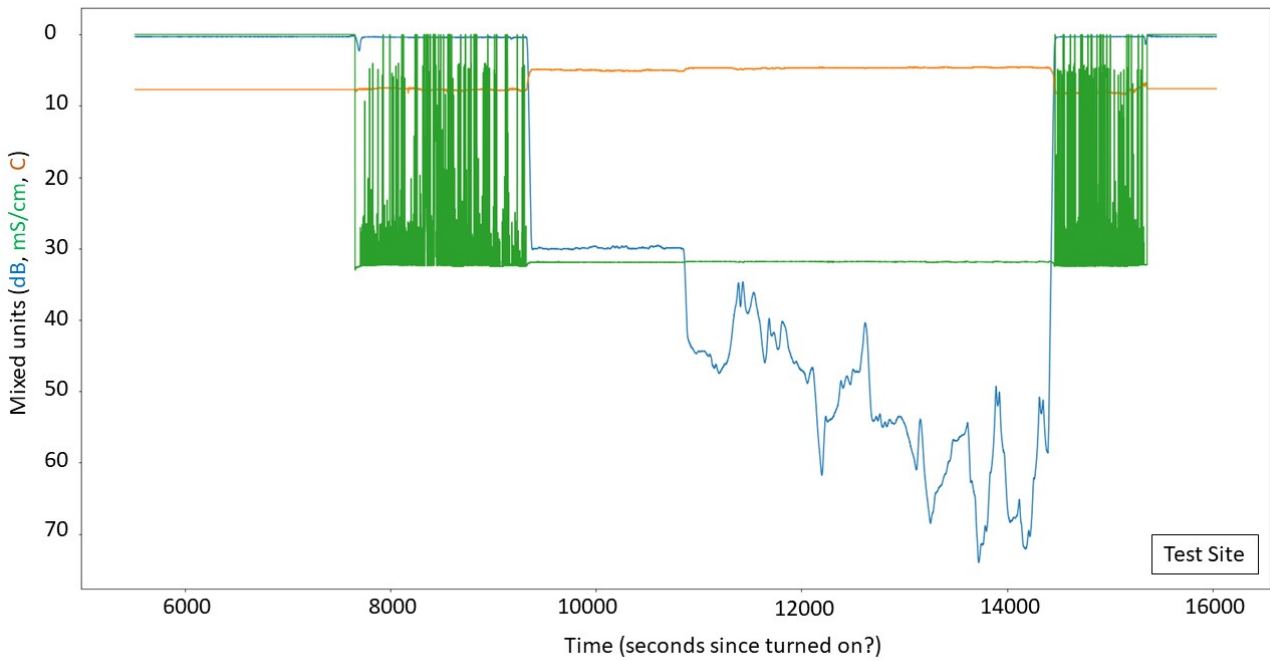
Overview CTD graph from the test site: Blue line: pressure (dB), green line: conductivity (mS/cm), orange line: temperature (C). The units are not specified in the files and are to be considered as reasonable assumptions. The x-axis is time, in mystery units. It might fit with seconds since the AUV was turned on. The "forests" in the conductivity data corresponds to time the AUV was spending in the sea, but on the surface, where the CT sensor was bobbing in and out of the water.

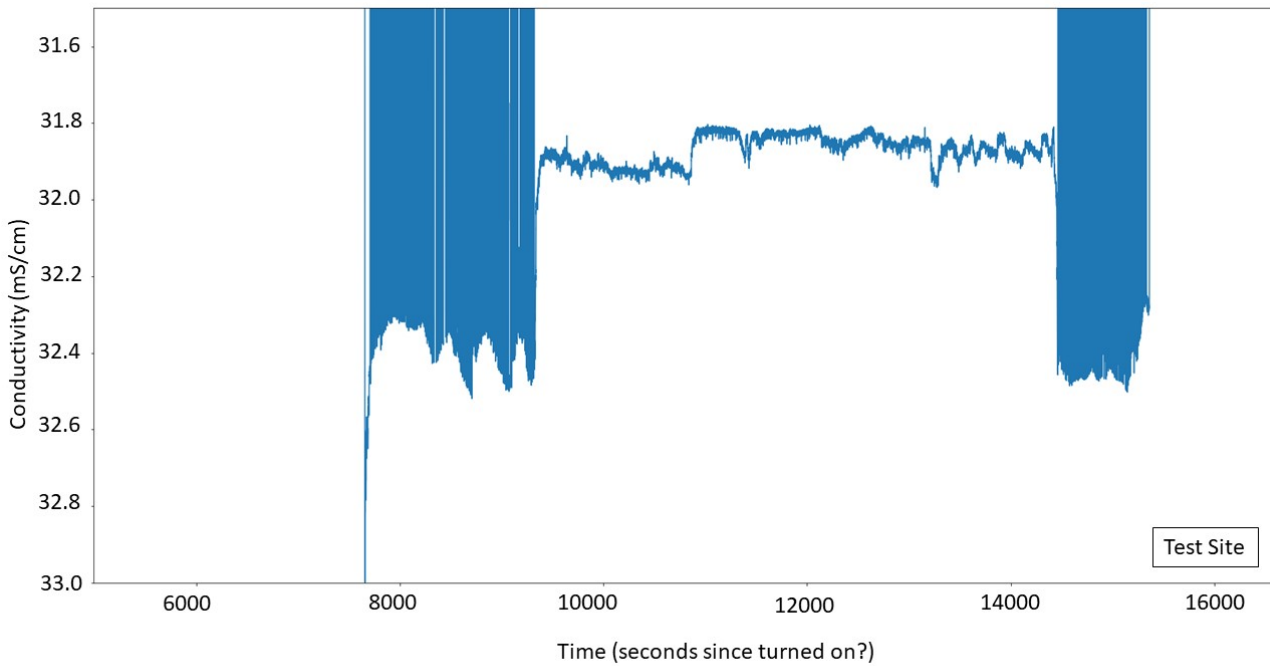
Conductivity versus time, zoomed in to show variation.

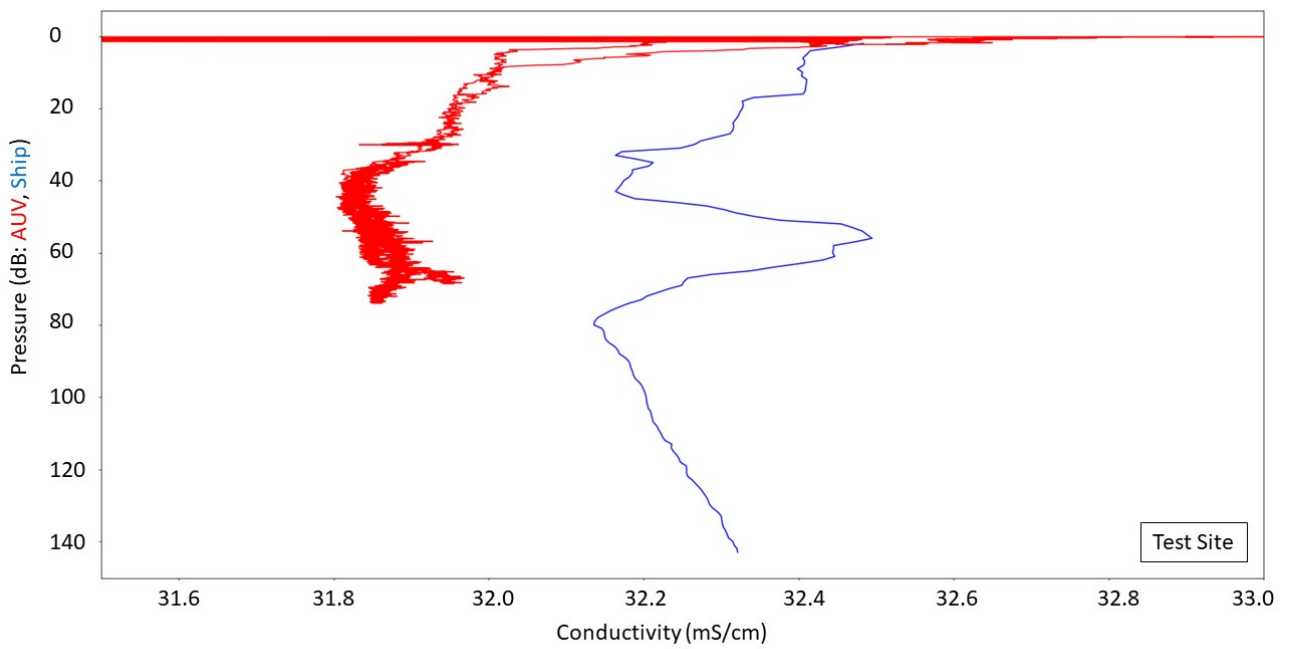
Comparison between shipborne and AUV conductivity. The shipborne CTD was taken in a deeper area slightly off the site. The ship CTD uses S/m units of conductivity – these have been multiplied with 10 to match the units from the AUV. The most glaring difference is an offset of about 1%. In the upper part of the water column, the profiles otherwise reproduce the general shape of the profile, and the spike at 30m depth. The thick part of the AUV graph corresponds to the AUV moving near the bottom, covering an extended area with varying depth. The shape of the profile here does not match that of the shipborne CTD well, but since the AUV test area is in a strait and, and the CTD station in deeper water, this might be due to real differences in the water properties.

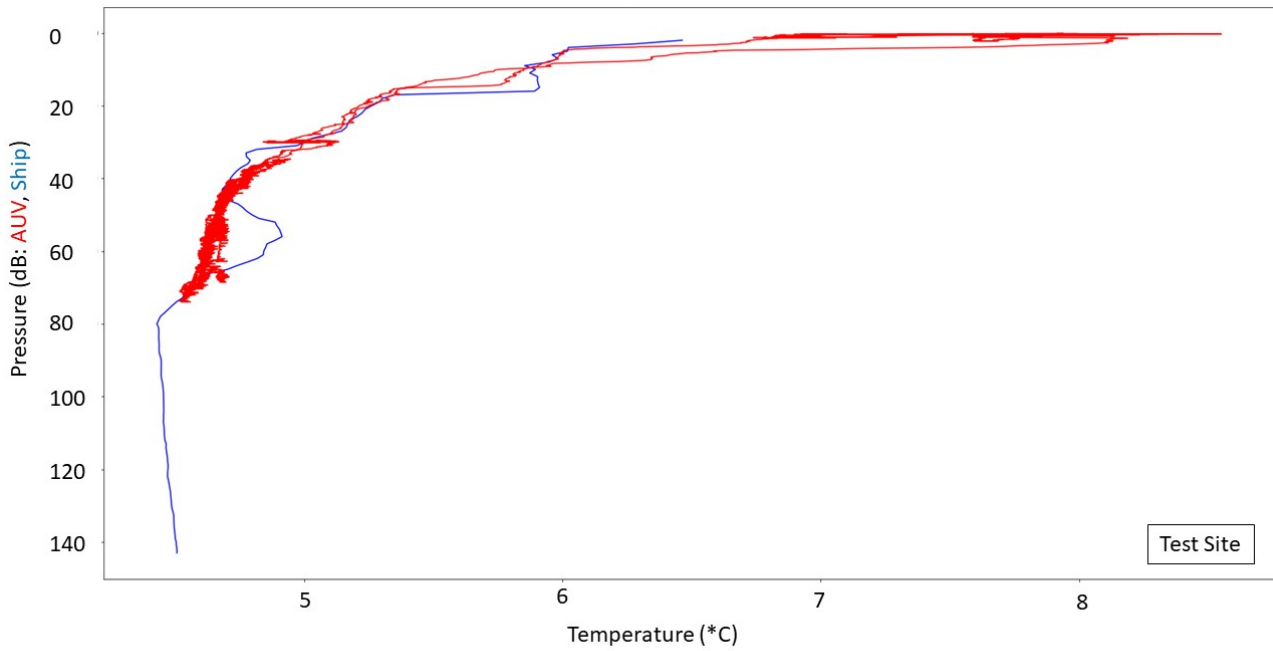
Comparison between shipborne and AUV temperature. The shipborne CTD was taken in a deeper area slightly off the site. Overall, the match is reasonable in the upper part of the water column. The feature in the shipborne CTD at 45-70m is not reproduced in the temperature profile either, but more resembles the AUV conductivity profile above. While the cause is unknown, it lends support to the hypothesis that the water properties really are different in the shallow and deeper areas.

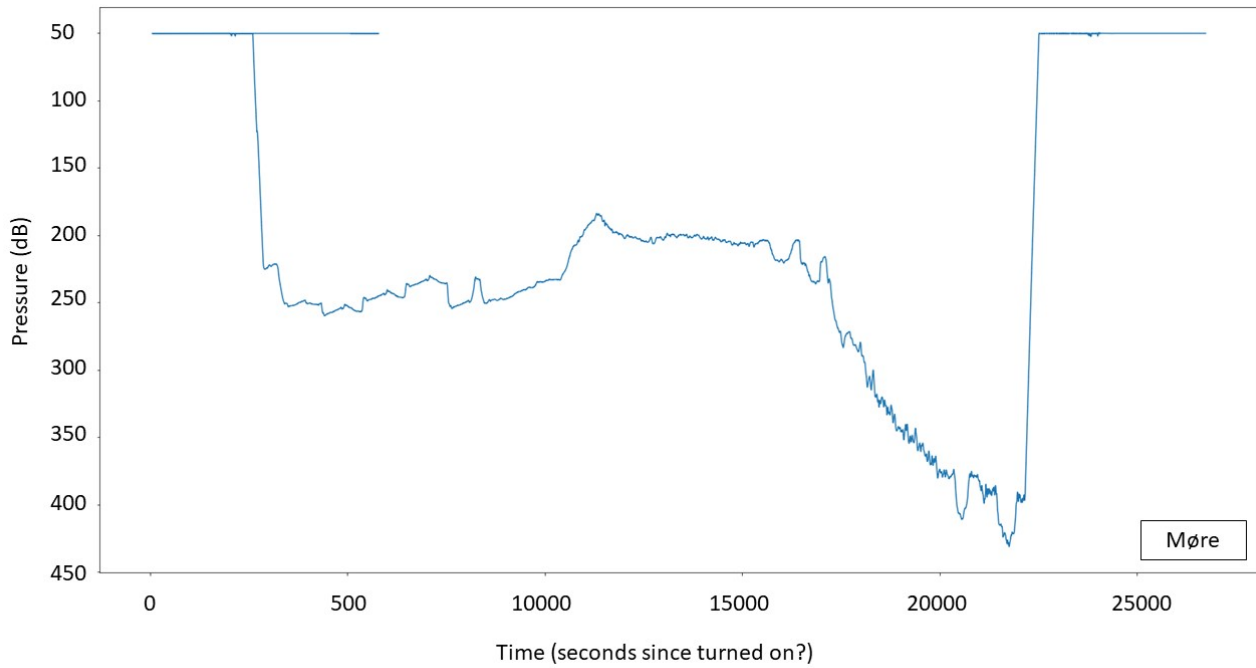
Depth (pressure) over time. The AUV was deployed on the shelf and did a couple of “mow the lawn” areas on the shelf before transiting down the slope to the final “mow the lawn” at a deeper level.

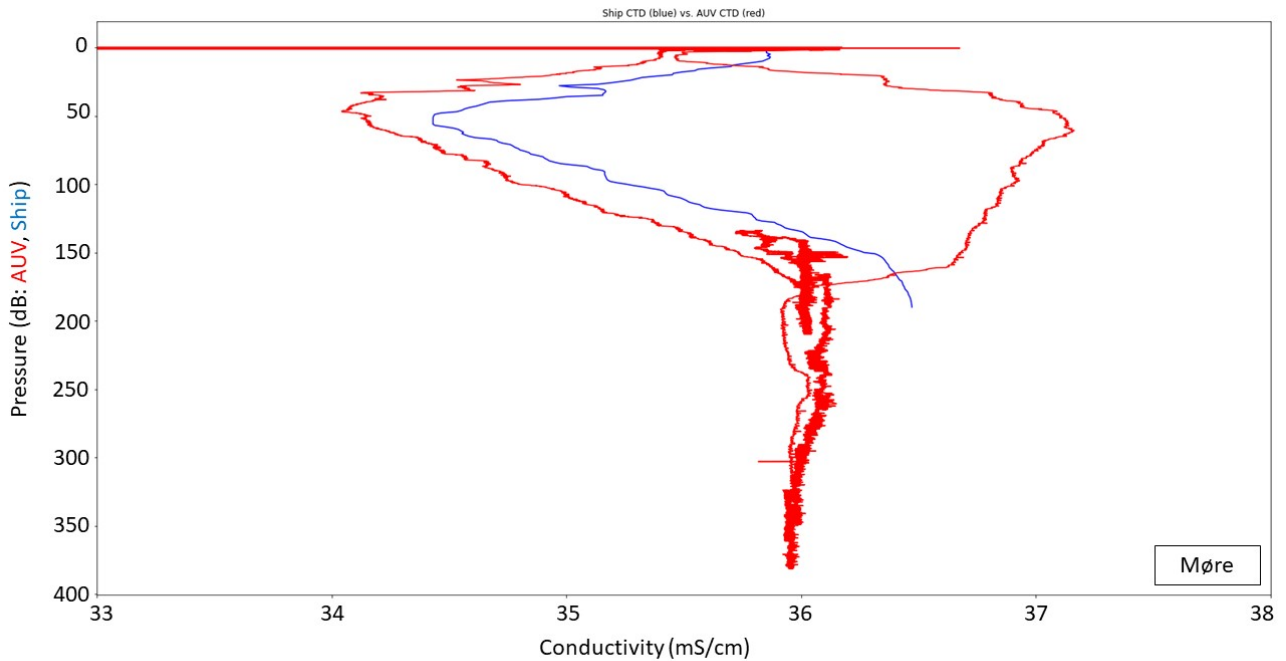
Comparison between shipborne and AUV conductivity. The shipborne CTD was taken on the shelf where the AUV was deployed. The ship CTD uses S/m units of conductivity – these have been multiplied with 10 to match the units from the AUV. Very apparent is an offset between the ship and AUV conductivity of about 1%. On the shelf, the profiles otherwise show a good correspondence. The shipborne CTD shows only downcast, while the AUV CT show both down- and upcast. The water properties are notably different on and off the shelf.

A possible reason for the conductivity offset could be that the AUV conductivity tube is contaminated with a coating of something, e.g. grease. After the Møre mission, the technicians cleaned the CT sensor with Triton X. Unfortunately, we did not manage to complete any further dives. {if the "and a bit" dive have any CT data, we can compare}

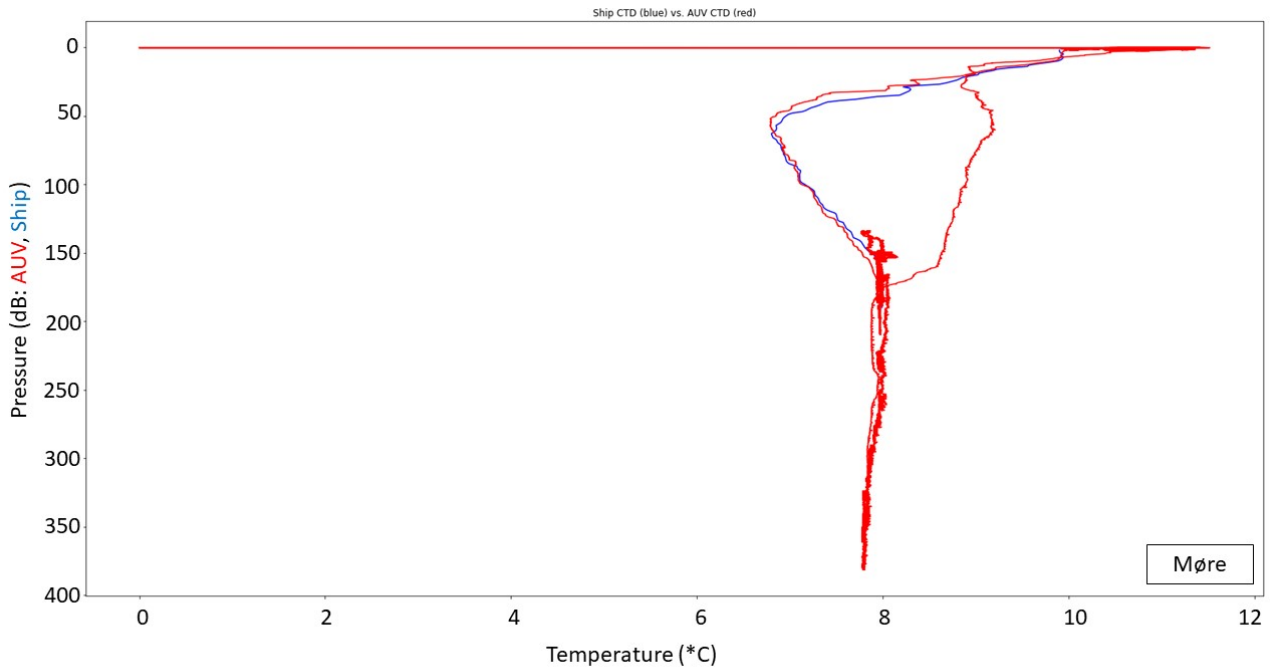
Comparison between ship and AUV temperature. The downcasts follow each other well, but it is possible that there is a small offset of some kind. It is also possible the difference is due to natural variation and a (small) difference in position and time of the two casts.
