CRUISE REPORT 2022106

MAREANO methods cruise: AUV testing (Munin +)

Author(s): Rebecca Ross, Kyrre Heldal Kartveit, Karsten Arne Kvalsund, Arnfinn Morvik (IMR), Margaret Dolan (NGU), Tor Jan Meek (Kartverket) and Ivar Wangen (Kongsberg)
Cruise leader(s): Rebecca Ross (IMR)

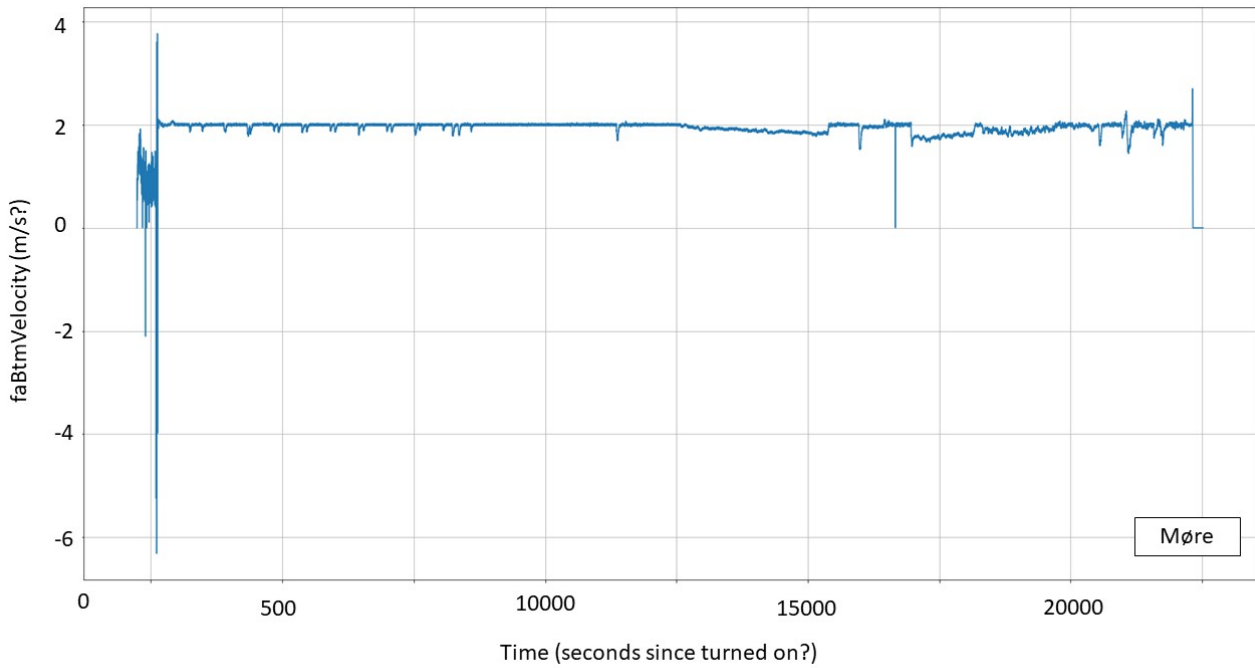
faBtmVelocity vs. time, assumed to be the bottom track velocity in the along-AUV direction. The velocity of about 2m/s(?) corresponds to the AUV speed of 4kn.

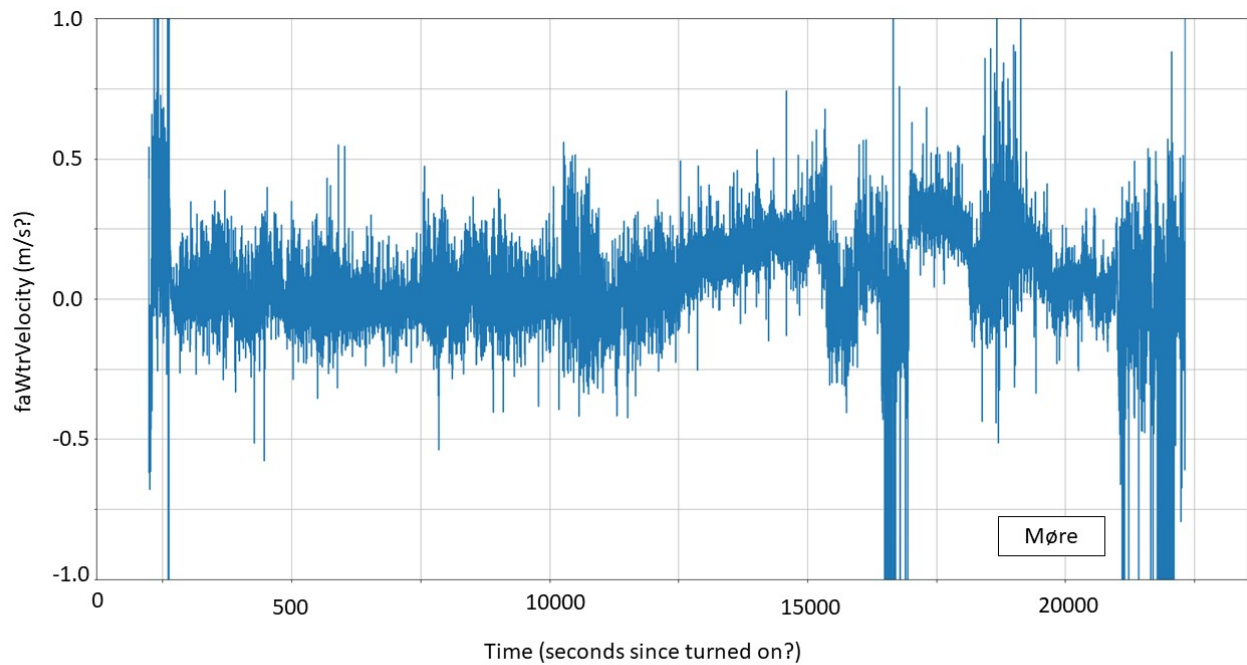
The parameter faWtrVelocity, assumed to be speed through water in the along-AUV direction, is very similar to faBtmVelocity. Subtracting faBtmVelocity from faWtrVelocity gives the above plot, with residual velocities. The magnitude of the residual current is within expectations from the shelf slope (up to ~0.70 m/s).

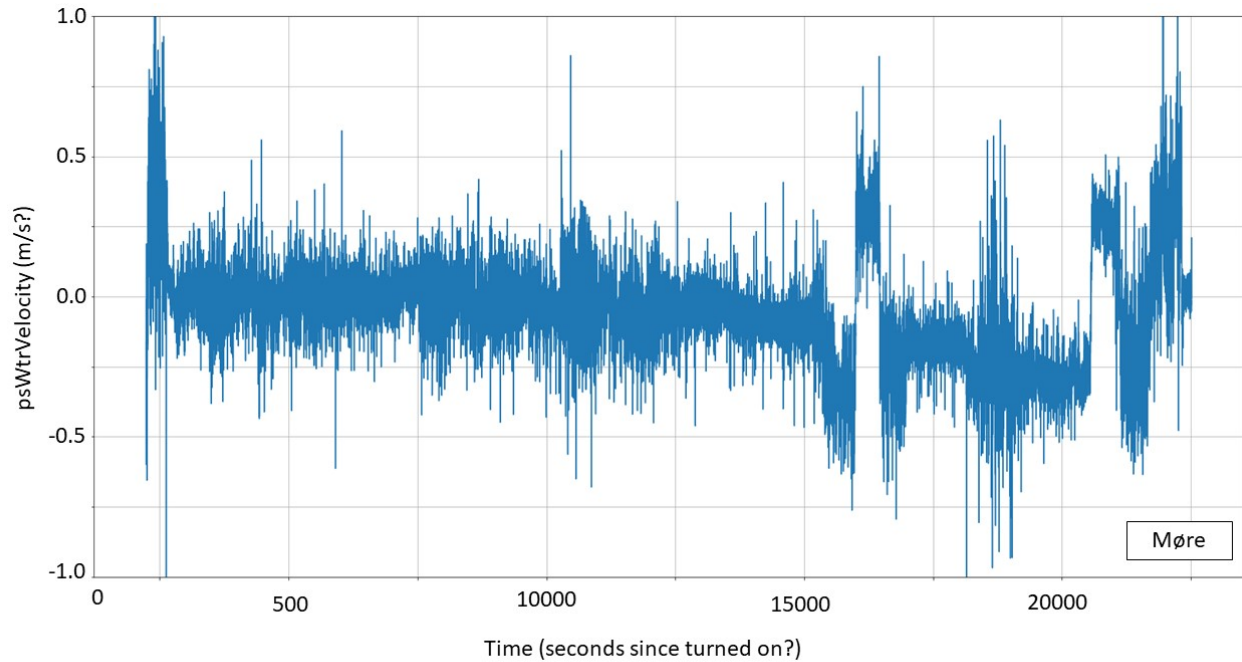
Above plot is $psWtrVelocity - psBtmVelocity$ (i.e. residual currents in the cross AUV direction). Again the magnitude of the current is plausible. The AUV descended the slope at an angle, so we would expect the slope current to be split between along- and across-AUV directions.

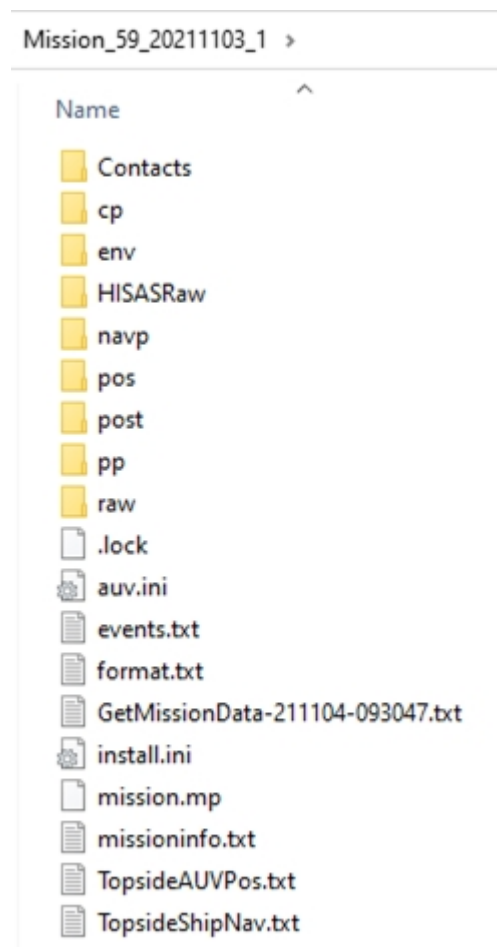
screenshot of a typical mission folder structure

NB The format file is useful for finding headers for any of the sensor data.

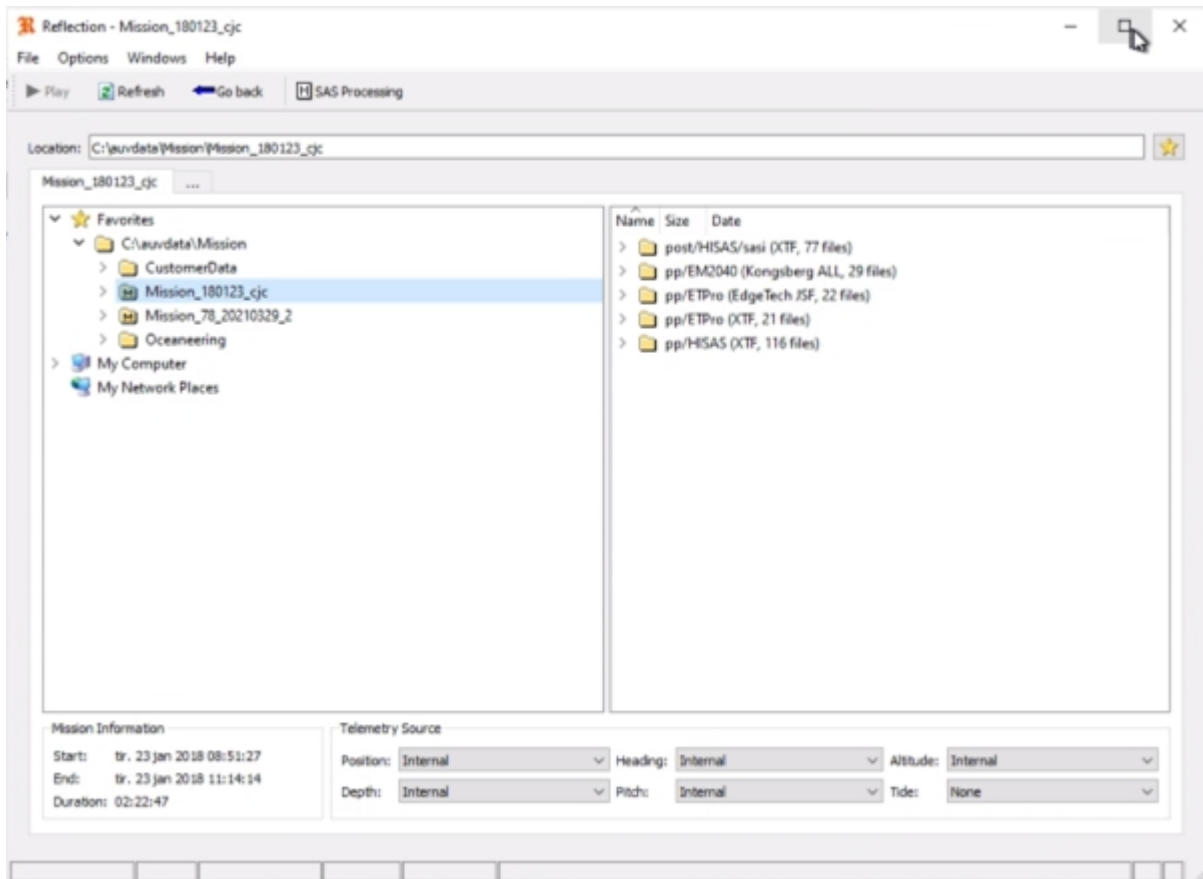
Screenshot of Reflection's file selection window - the start point when trying to view AUV data

Within subfolders you can select file to visualise and you can use the dropdown menus at the bottom to modify various options e.g. whether you used processed or unprocessed navigation data. You will then press play to view the data and are automatically shown the right type of viewer for that data.

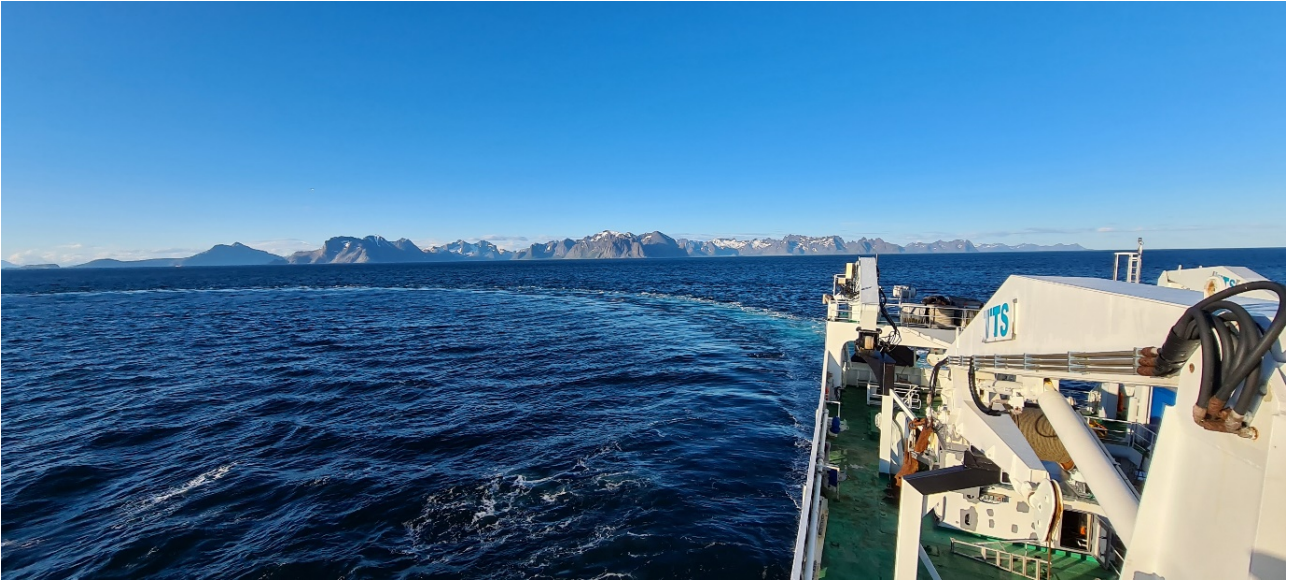
Doing ADCP calibration circles in ideal conditions under the midnight sun. Photo taken by Ivar Wangen

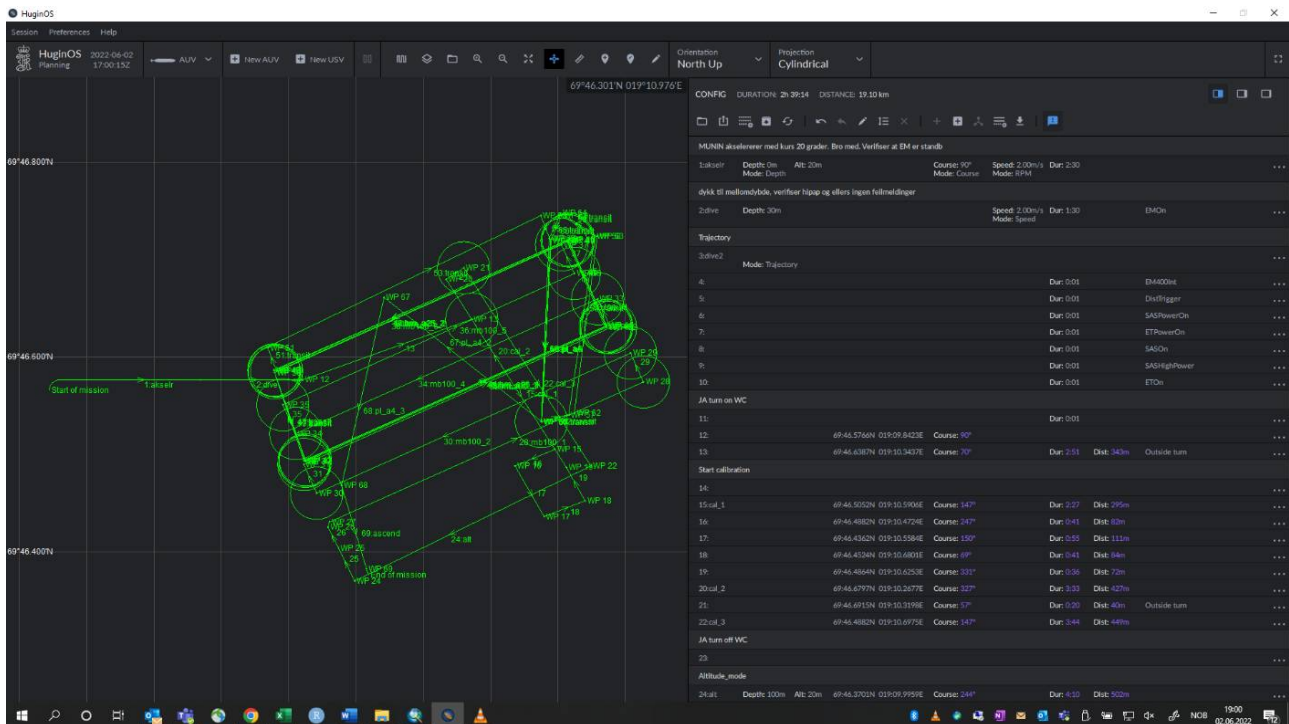
Screenshot of HuginOS and the planned dive track and instructions for the test site

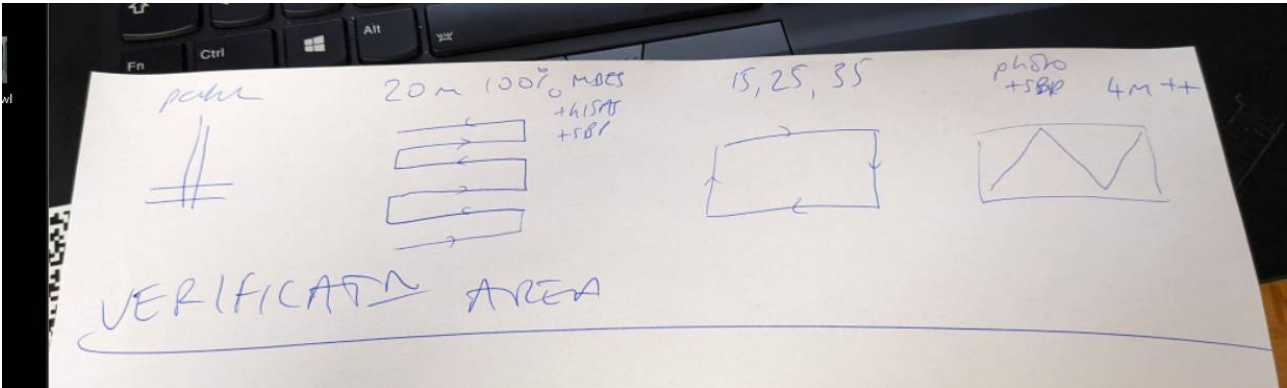
Visualisation of planned tests for the test site dive. Photo R Ross

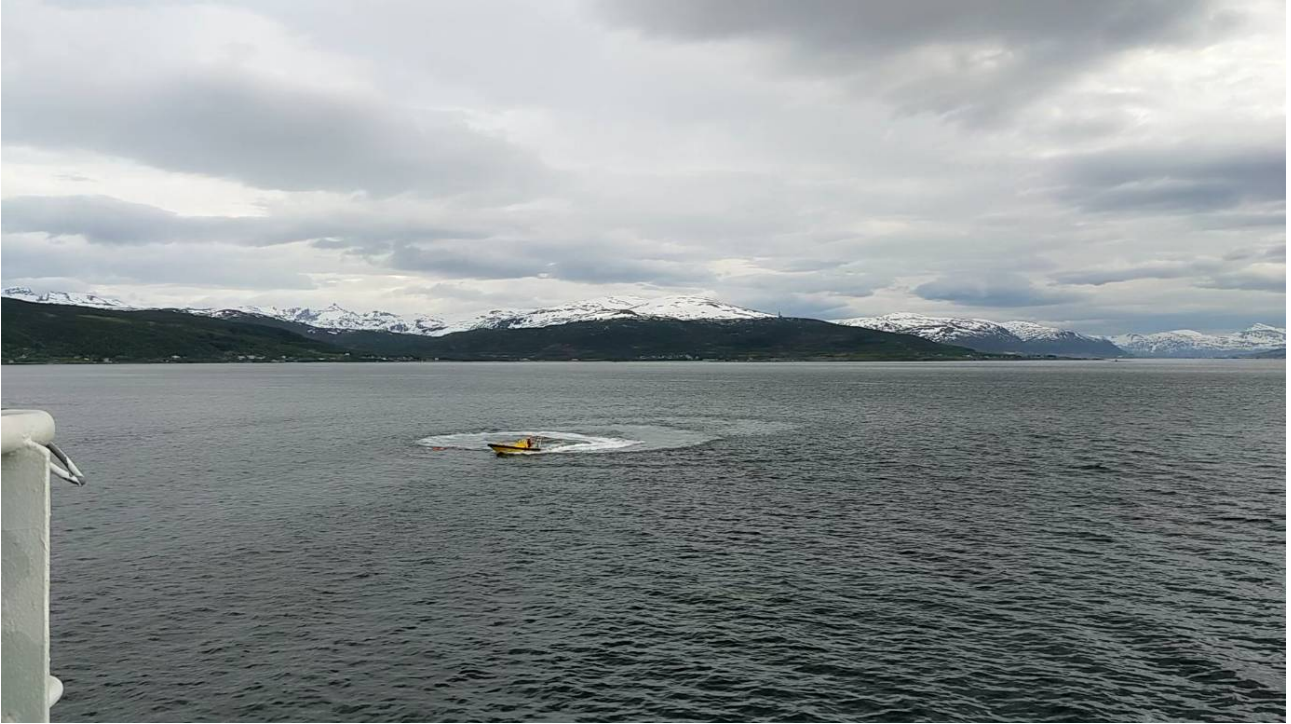
MOB boat doing circles around the AUV. Photo R Ross

- **Currently the Munin+ will not be able to dive if the conditions are too calm**. We used the MOB boat to run circles around the Munin+ in order to make enough waves to allow it to tip beneath the surface. This will hopefully be rectified before future work, Kongsberg have already suggested a new propeller to address this.

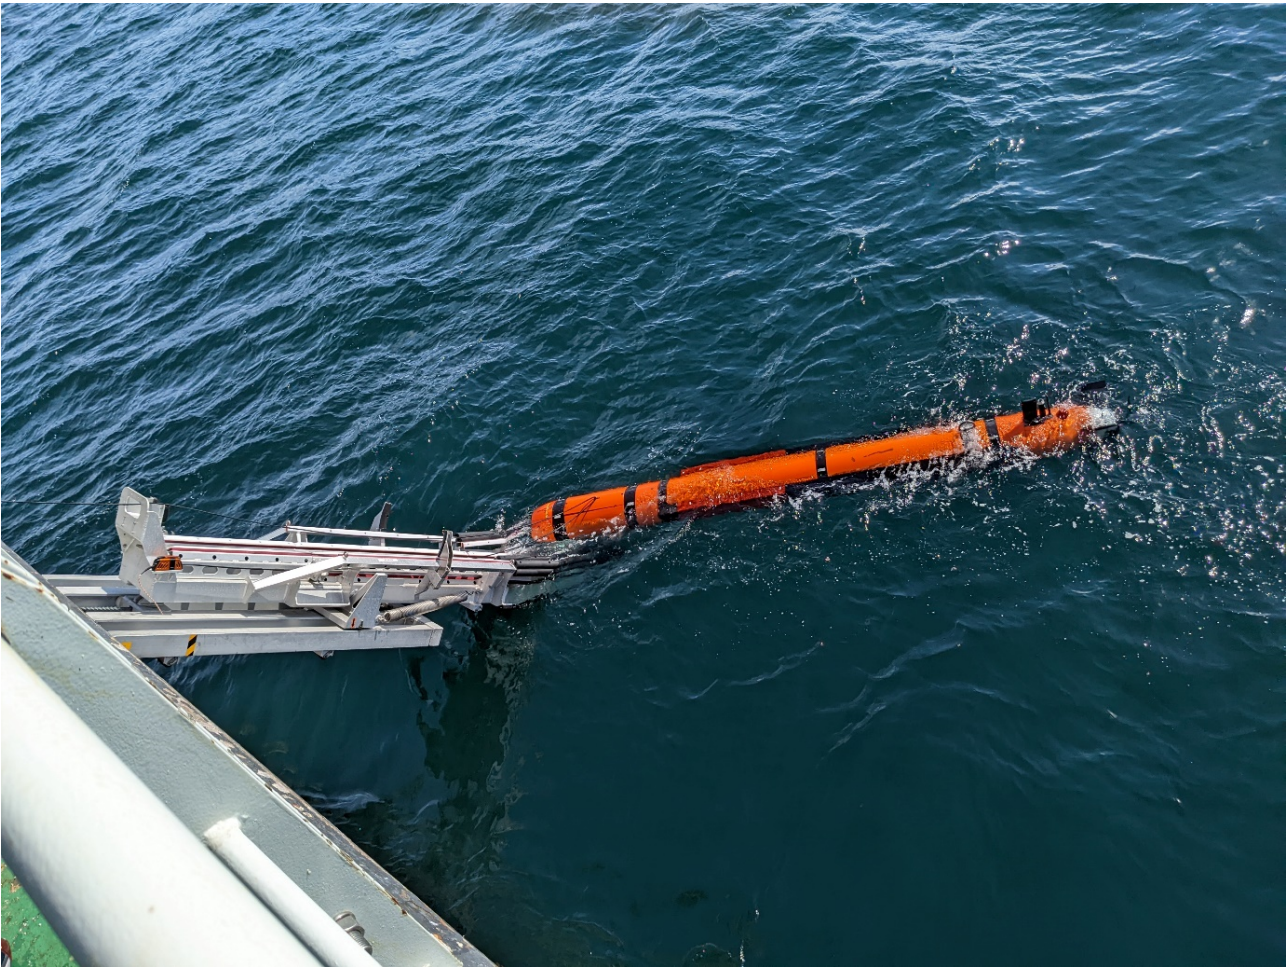
AUV leaving the stinger viewed from the deck above. Photo R Ross

- Suitable **weather/wave conditions are more restricted than using Chimaera/ an ROV**. The AUV stinger that launches and collects it is the main issue, especially during collection when it may crush the AUV if the wave conditions are not calm enough.

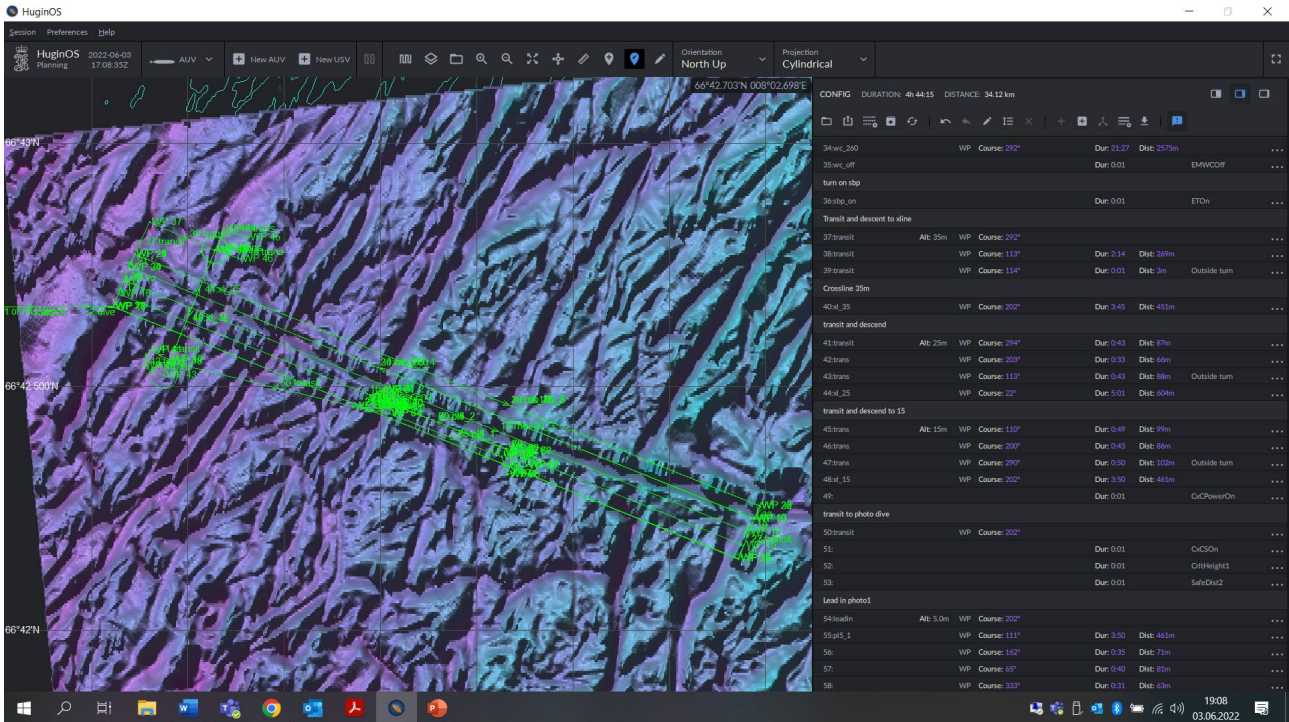
Planned dive at Perlekjederev (in HuginOS)

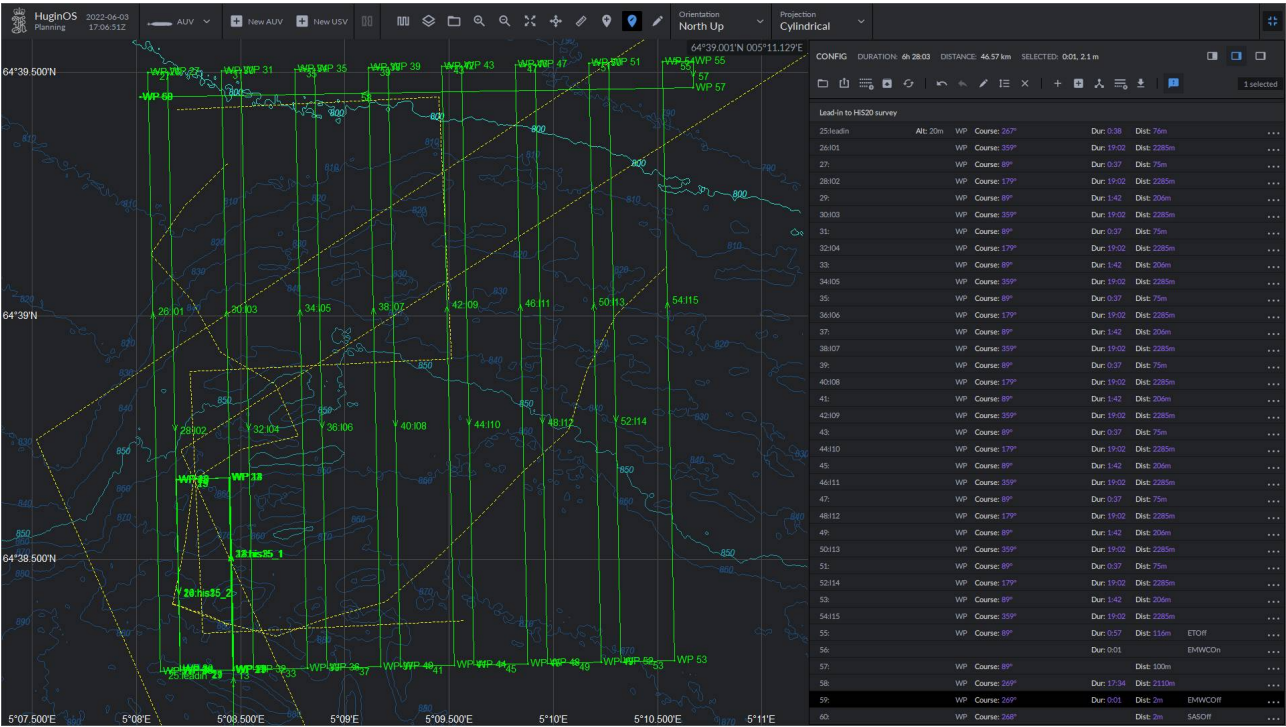
HuginOS screenshot of AUV6 dive plan

In the meantime, we have planned dives at AUV6 and AUVT1. AUV6 now includes 4 heights of HiSAS around a circuit that is ~700m x 300m and mapped over the video line for groundtruthing to provide the heights test that we have not managed to do at the previous 2 sites. Then the rest of the site is in mow-the-lawn pattern for 100% HiSAS coverage with 20m height, followed by a crossline where SBP is switched off and water column MBE is turned on (assuming that it was SBP that interfered with the watercolumn at the test site). This will allow a test of WC over soft bottom. One VL is covered in this area, together with the two 5km template photo dive patterns proposed by Jackson Shields and Oscar Pizarro. An expert-led 5km rout will also be added to the photodive after evaluating the features seen in the acoustics. The acoustic dive should be 6.5hrs long. AUVT1 is planned to follow the turning route that captures multiple video lines and bisects multiple planned boxes/features and climbs several slopes of varying degree to test how the AUV handles this (including in the edge of AUV6 which was reduced in size to accommodate time constraints). The height of acquisition will be decided after the AUV6 results.

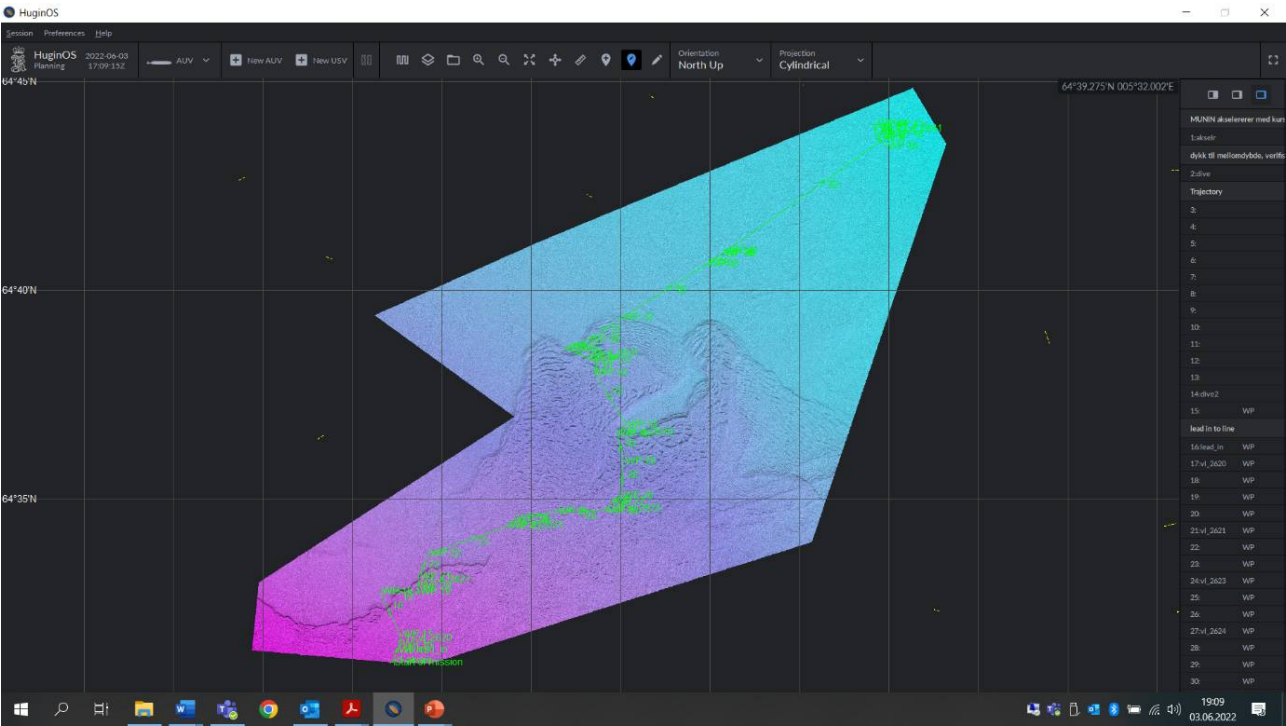
HuginOS screenshot of AUVT1 dive plan

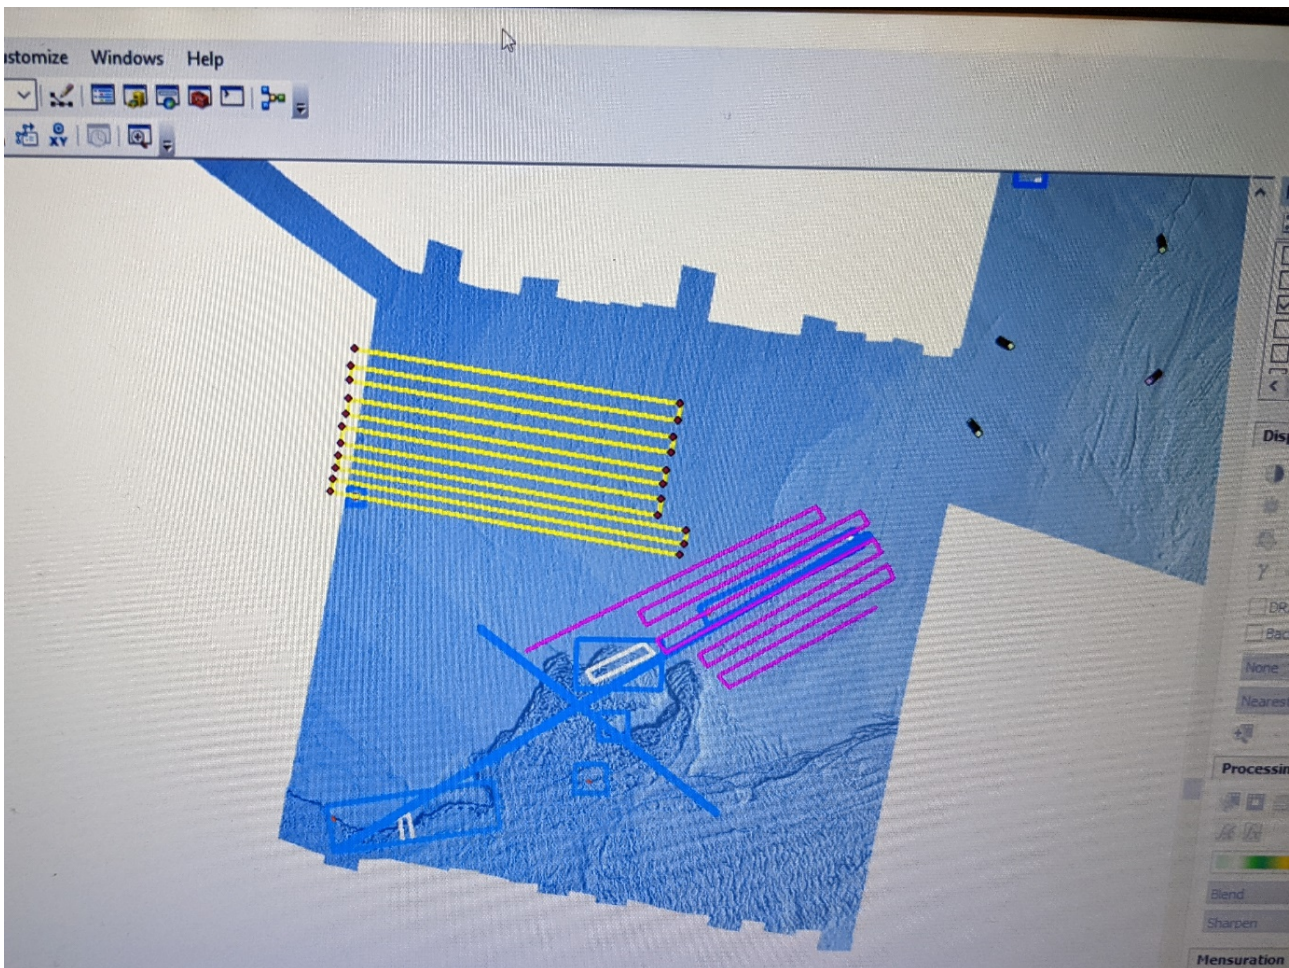
Planned SBP/WC MBE surveys in pink (the first) and yellow (the second)

Shyam had recently designed a survey pattern for use at night to acquire sub-bottom profiler and water column MBE data more densely around pockmark fields within BO1, so we began at kl. 09:35 with this surface vessel based acoustic survey instead of doing the AUV dives. Once this had begun it became clear that water column data was likely to be too bad, so that was only collected on the first line, and then tested again later on. Sub-bottom data looked acceptable, particularly when driving SW to NE with the wind behind the vessel, although as the wind increased the quality decrease on the NE to SW legs such that we instructed mid-way down the 4th line (a NE to SW leg, ~15:40) that the vessel speed back on NE to SW legs and focus on collecting data in the SW to NE direction. This has resulted in every other leg being collected with adequate quality, and the vessel was instructed to return to collect the poor-quality NE to SW legs in a SW to NE direction. After this the vessel will move on to a secondary similar pattern. By 18:50 the wind was beginning to lessen (peaked around 15 m/s, then 10 m/s) so we planned to return to AUV6 in the morning with the hope that we can begin with the first test dive at the start of the shift (kl. 08:00). Most of the team relaxed throughout the day, especially as more challenging conditions left some feeling unwell. Luckily no serious cases of seasickness were reported.

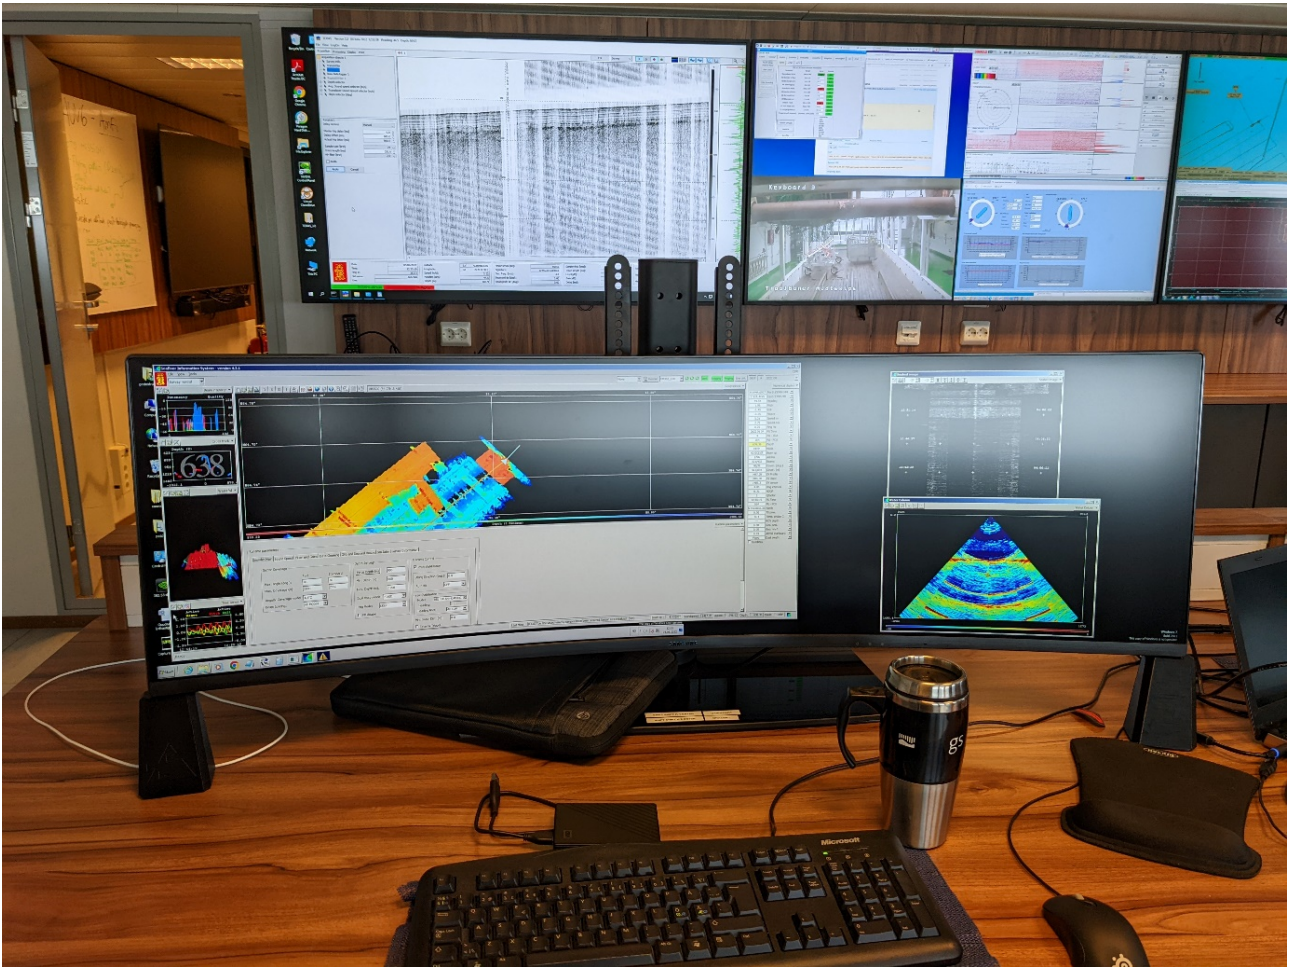
Collecting SBP and WC MBE on the first leg of the pink pattern in previous image. Photo R Ross

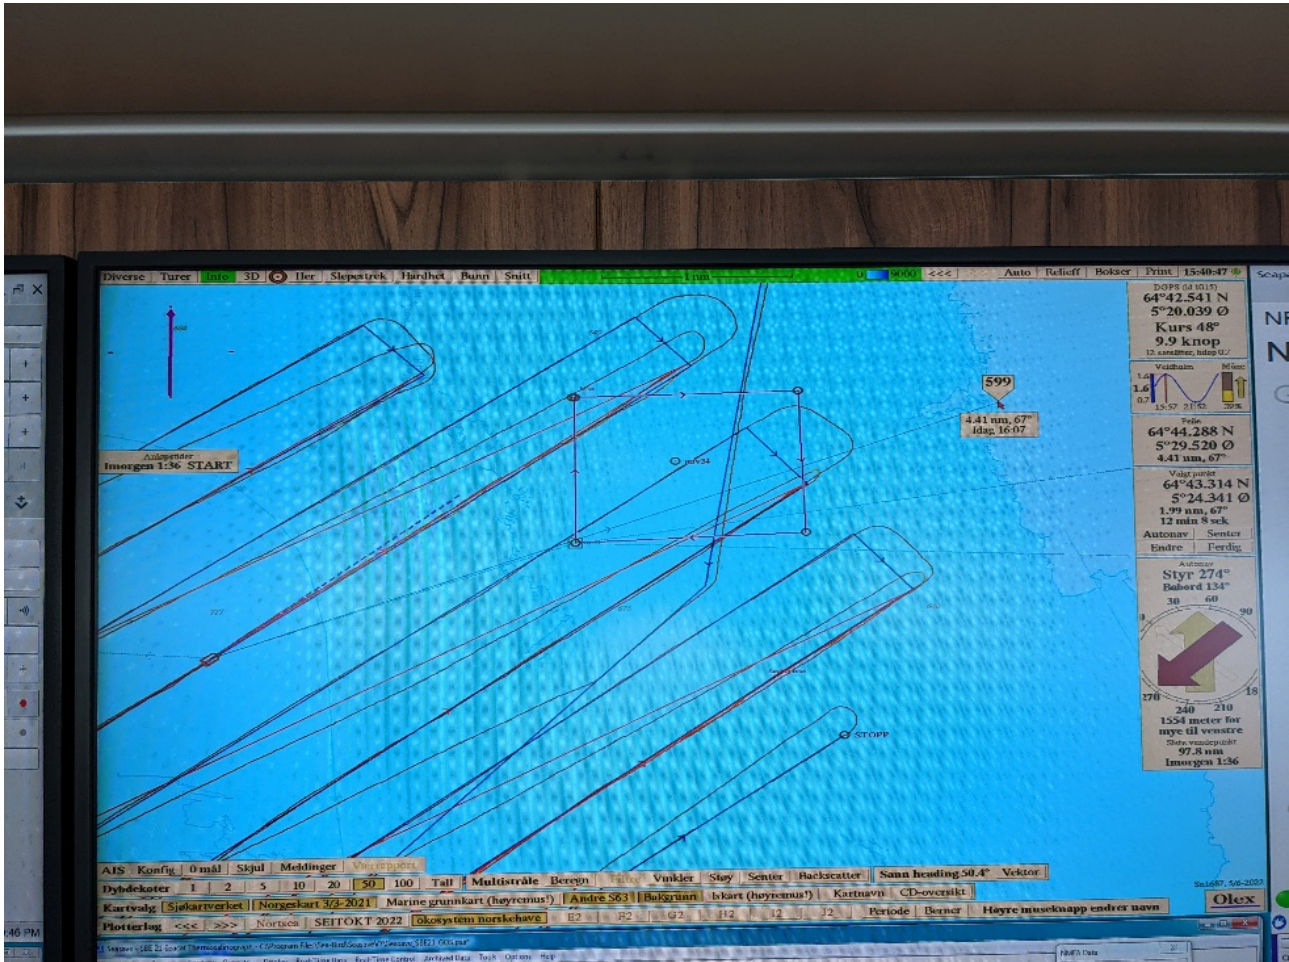
Olex screen showing planned SBP lines and the square around AUV34

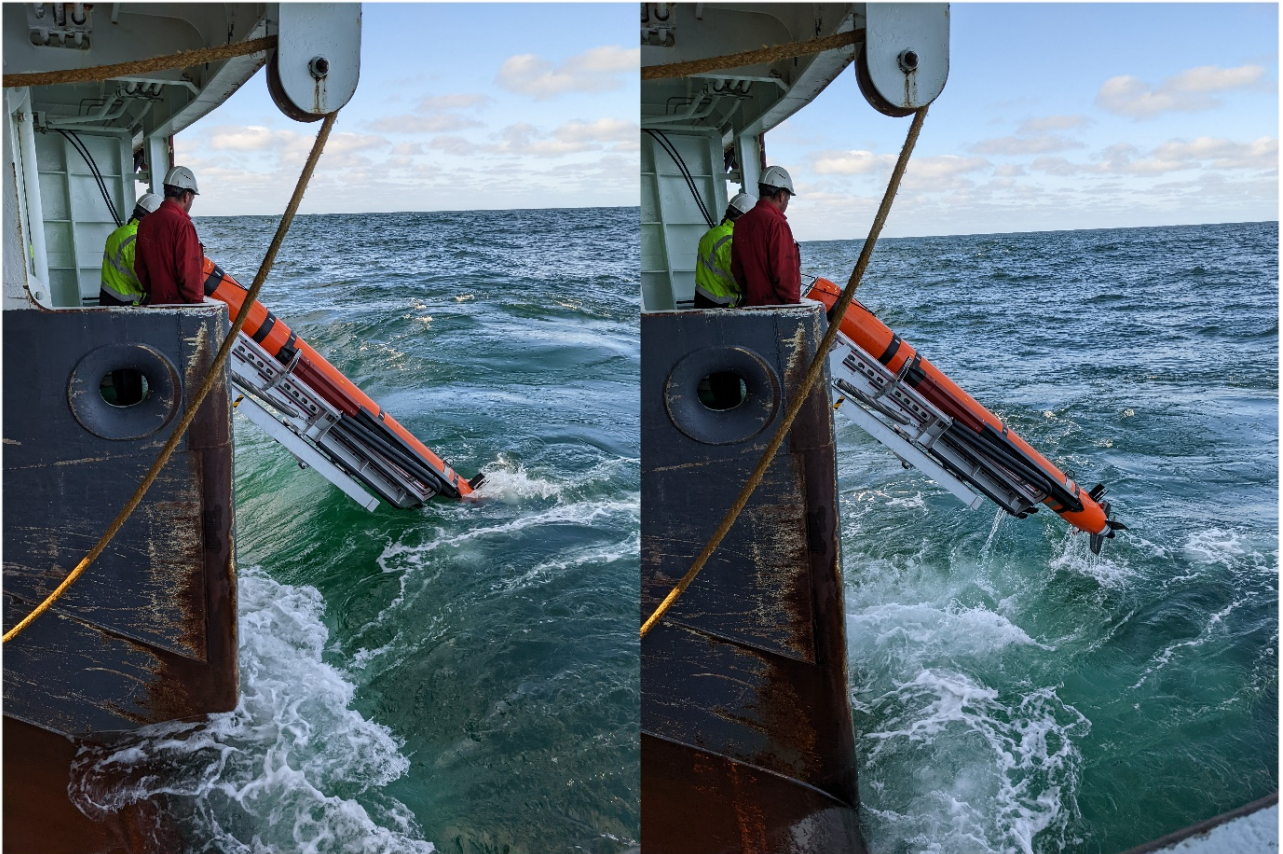
Launching the AUV into large swell - borderline conditions for AUV launch. Photo R Ross

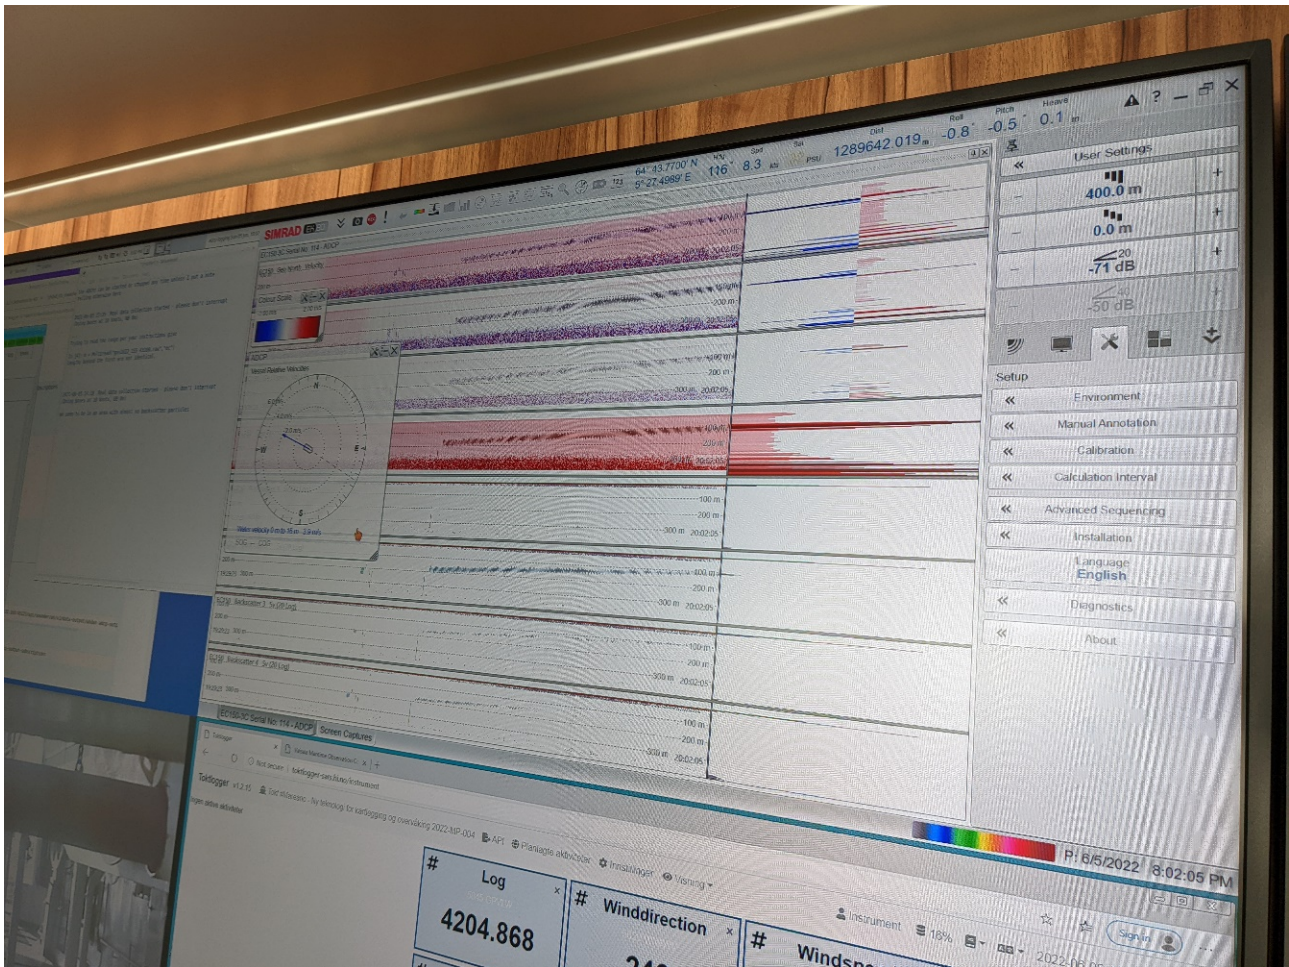
Limited backscatter in the water is reducing ADCP effectiveness in this area

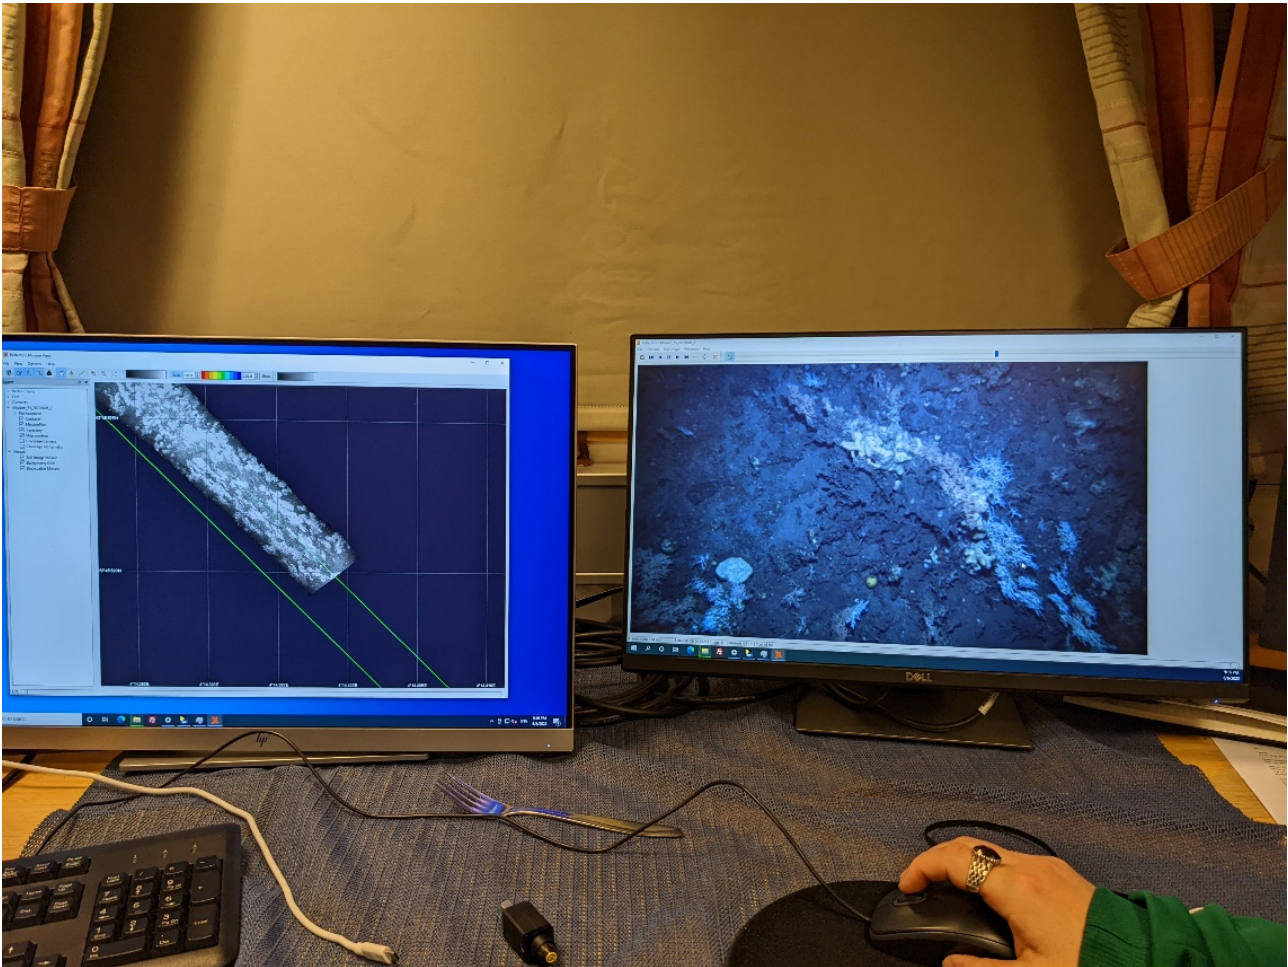
Successful collection of reef imagery at AUV Møre. Photo R Ross

Photo lines have been tested successfully at 6m, 5m and 4m altitude, although note that despite having 4m altitude set at AUV Møre the rough terrain of the coral reef on a slope meant that the AUV did get to within 2.6m of the bottom at one point before recovering and re-gaining the programmed 4m altitude. Lower altitudes are therefore not recommended on rough terrain, but could be possible on flat sediment bottoms.
